***Re: Phase II MS4 Annual Report Transmittal for the County of El Paso TPDES Permit Authorization:  
TXR040202***

# Phase II (Small) MS4 Annual Report Form

TPDES General Permit Number TXR040000

Authorization Number: TXR040202

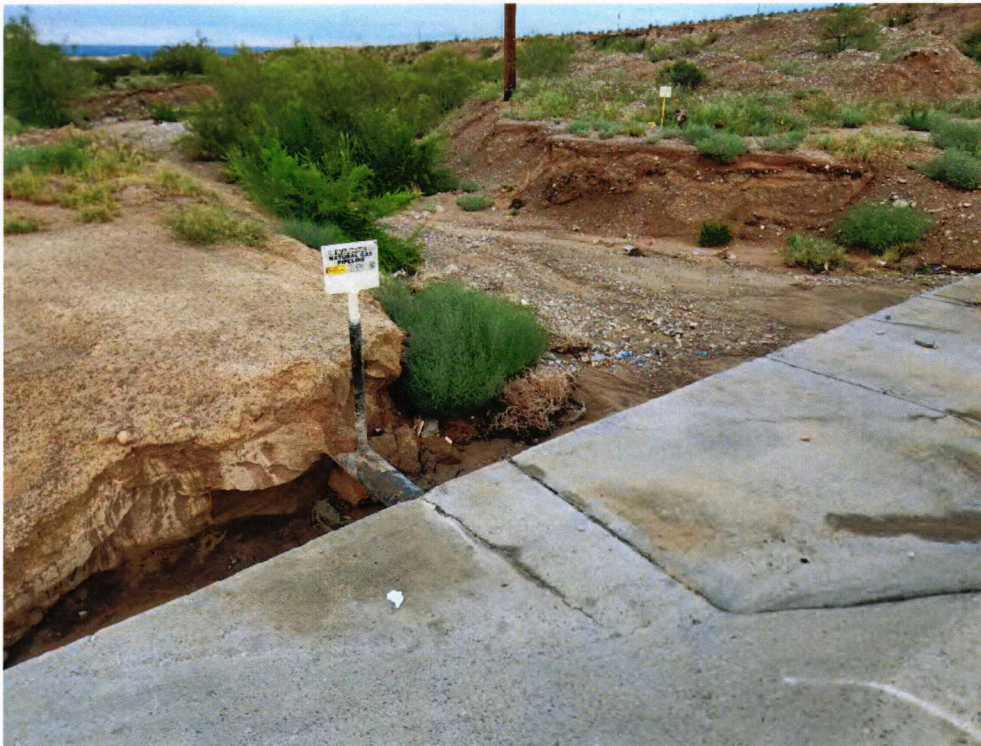
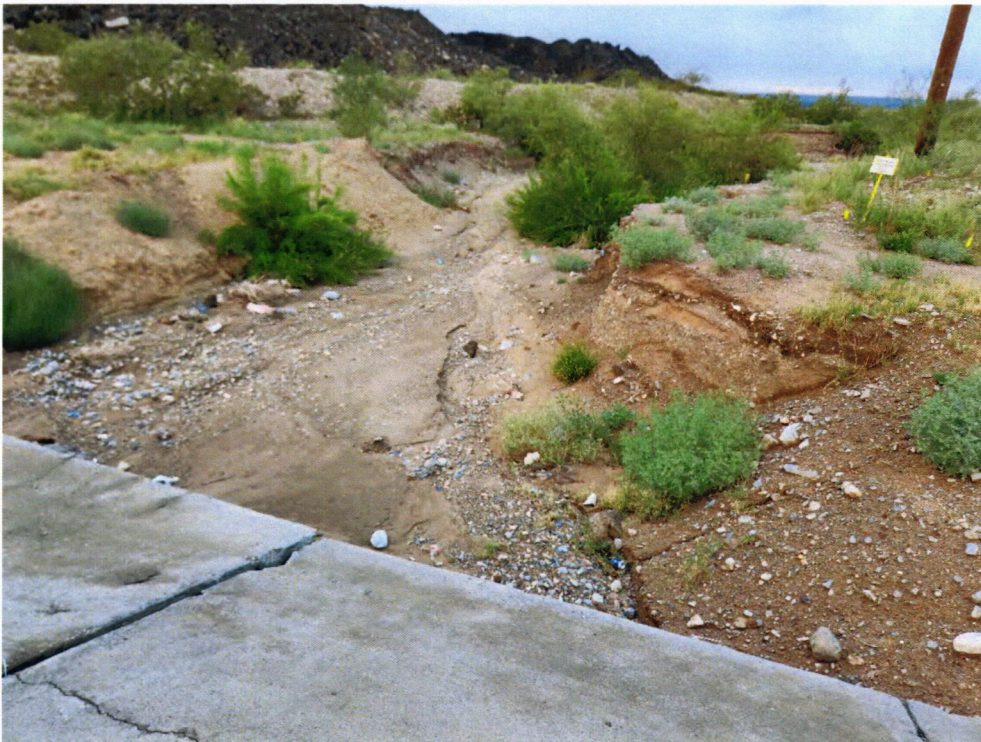
*Photographs 1 and 2 – 1-7 UP, dry, local geology is gravelly and sandy (8/18/2022).*

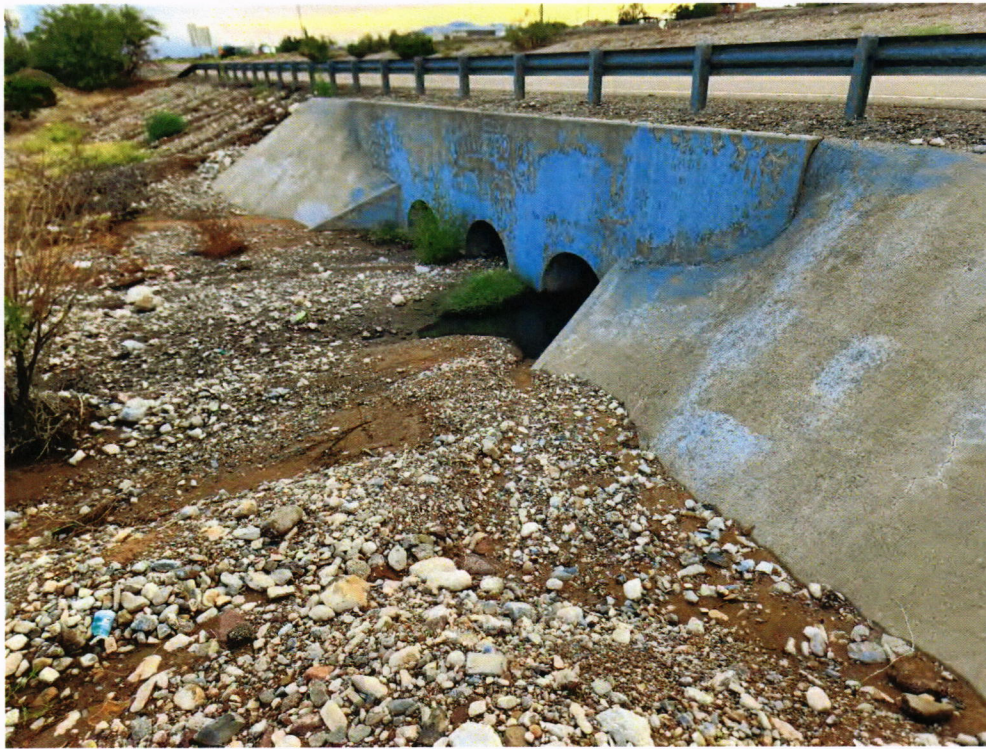
*Photograph 3 – 1-6 UP, standing water (8/18/2022).*

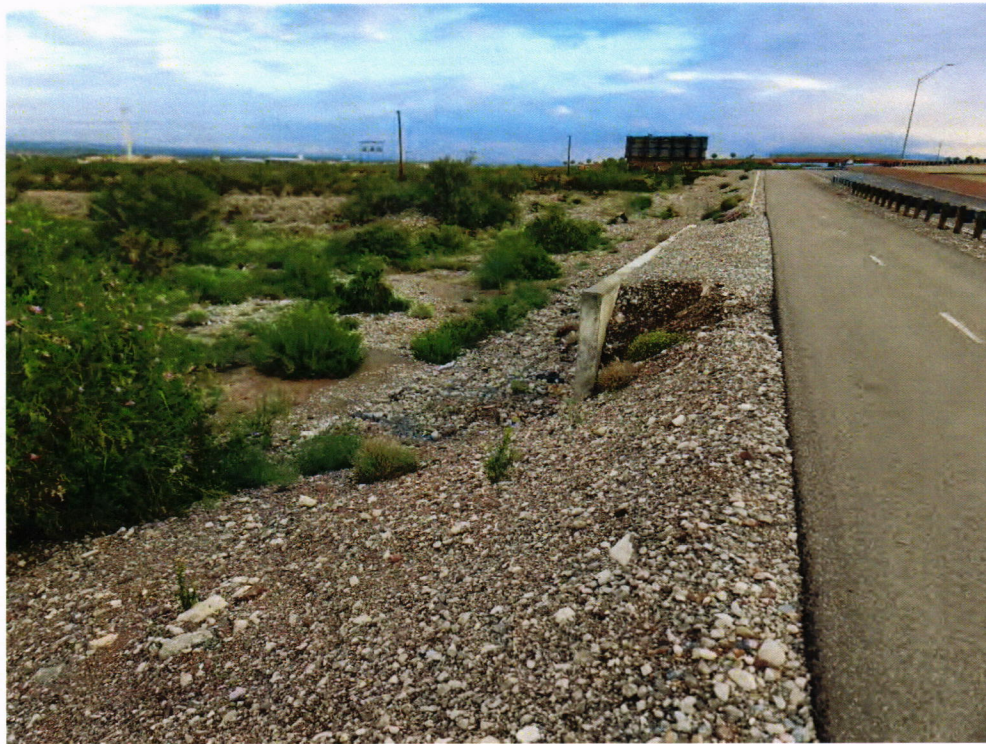
*Photograph 4 – 1-5 UP, dry (8/18/2022).*

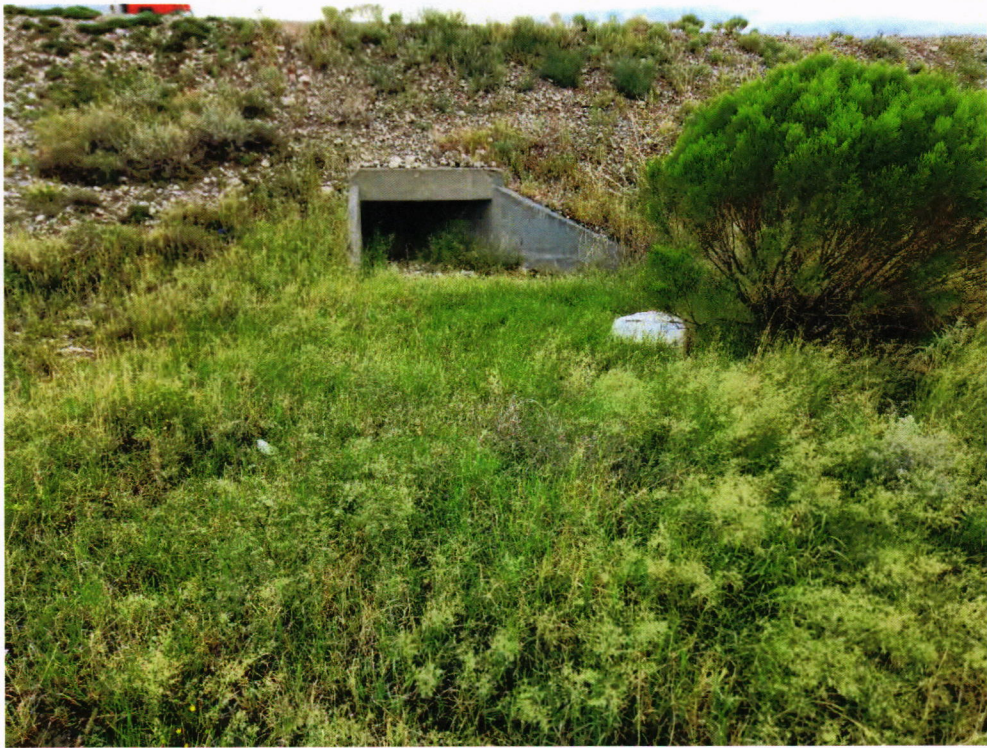
*Photograph 5 -1-4 UP, dry (8/18/2022).*

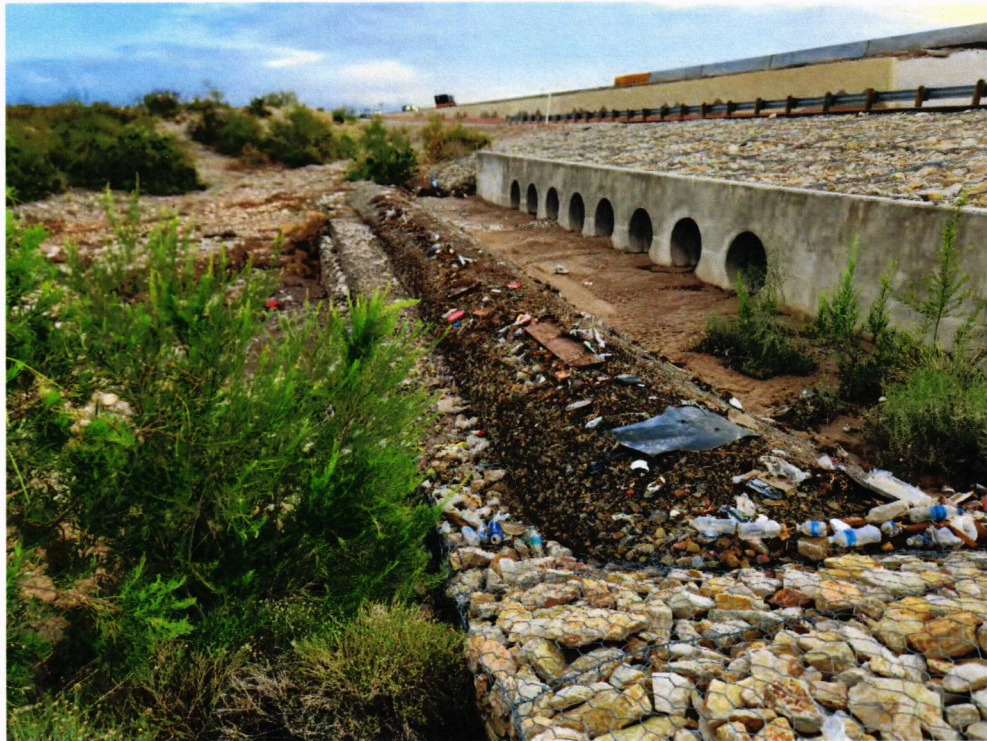
*Photograph 6 -1-3 UP, dry (8/18/2022).*

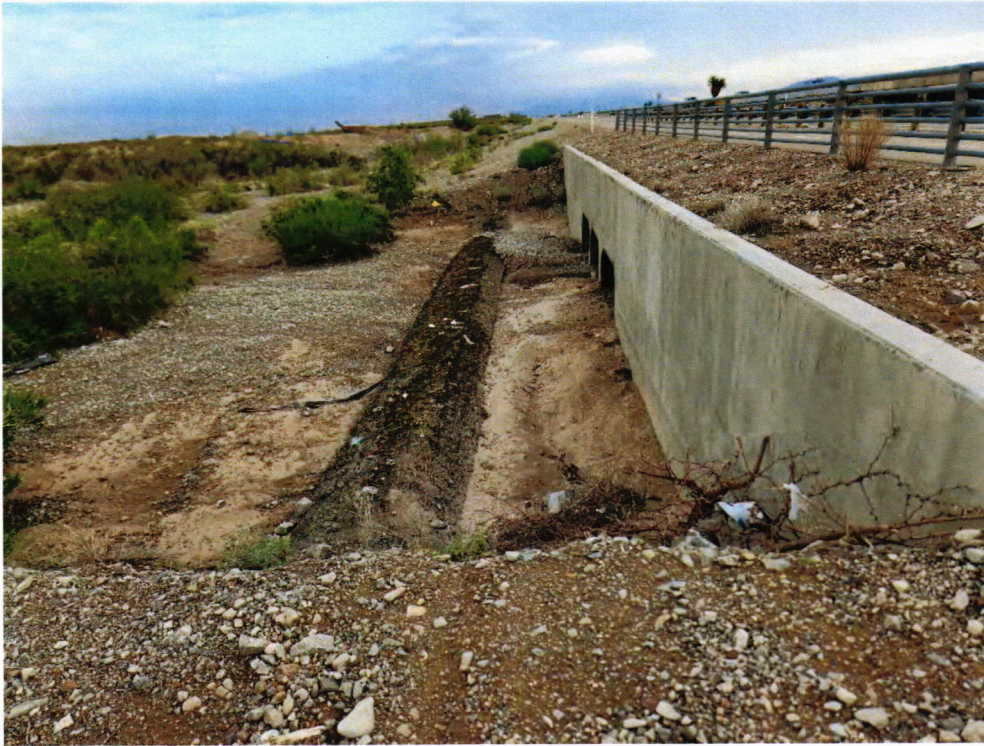
*Photograph 7 – 1-2 UP, dry (8/18/2022).*

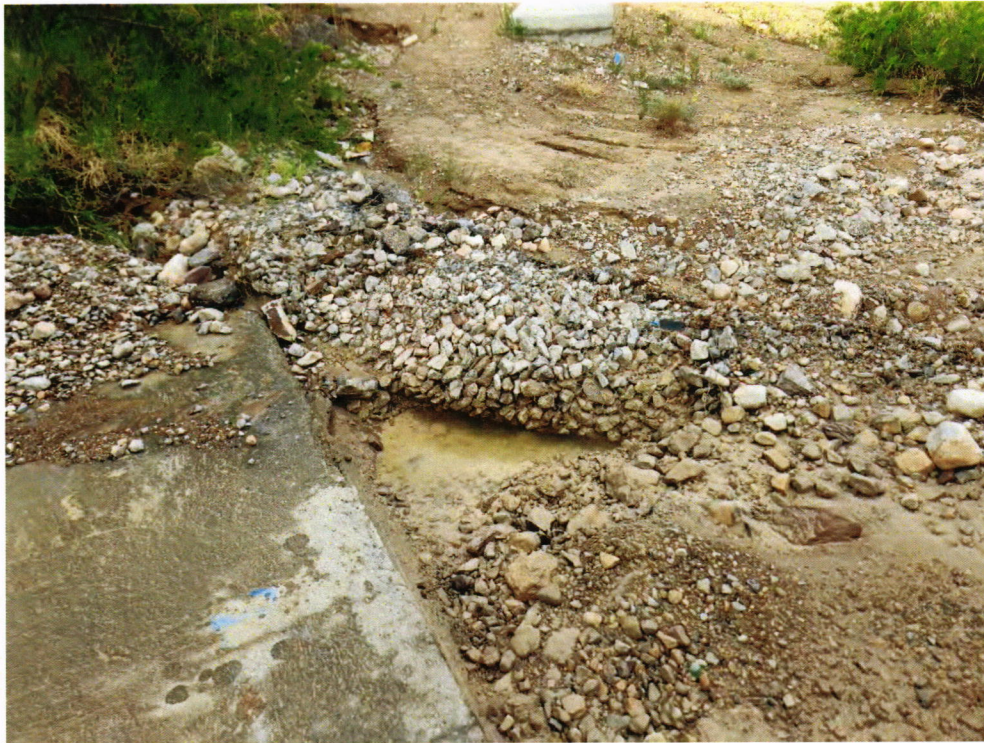
*Photograph 8 – 1-1 UP, standing water. (8/18/2022).*

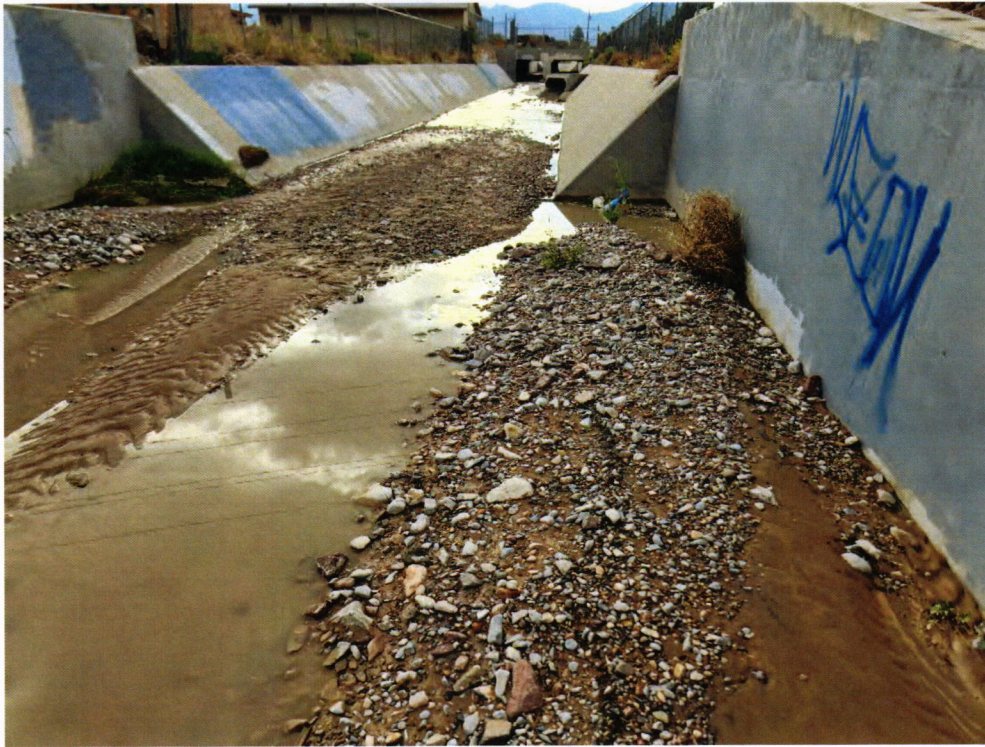
- 1-1 MID had a measured concentration of 1,986.3 MPN/100ml. Recent Google imagery shows this location within a natural arroyo. However, this sample location is near a recently completed concrete retention pond that has interrupted the continuity of the arroyo towards the Rio Grande. A pungent odor was noted during the site reconnaissance and sampling at 1-1 UP (measured 648.8 MPN/100ml).
- 1-2 MID had a measured concentration of 1,299.7 MPN/100 ml. Like 1-1 MID, the sample was taken in a location upstream of a concrete retention pond.
- 1-6 UP had a measured concentration of 2,419.6 MPN/100 ml. This arroyo appears to begin at Interstate 10. Historical topographic maps show that housing to the east was constructed over this arroyo between 1955 and 1967.

*Photograph 9 – 1-1 MID, standing water (8/18/2022).*

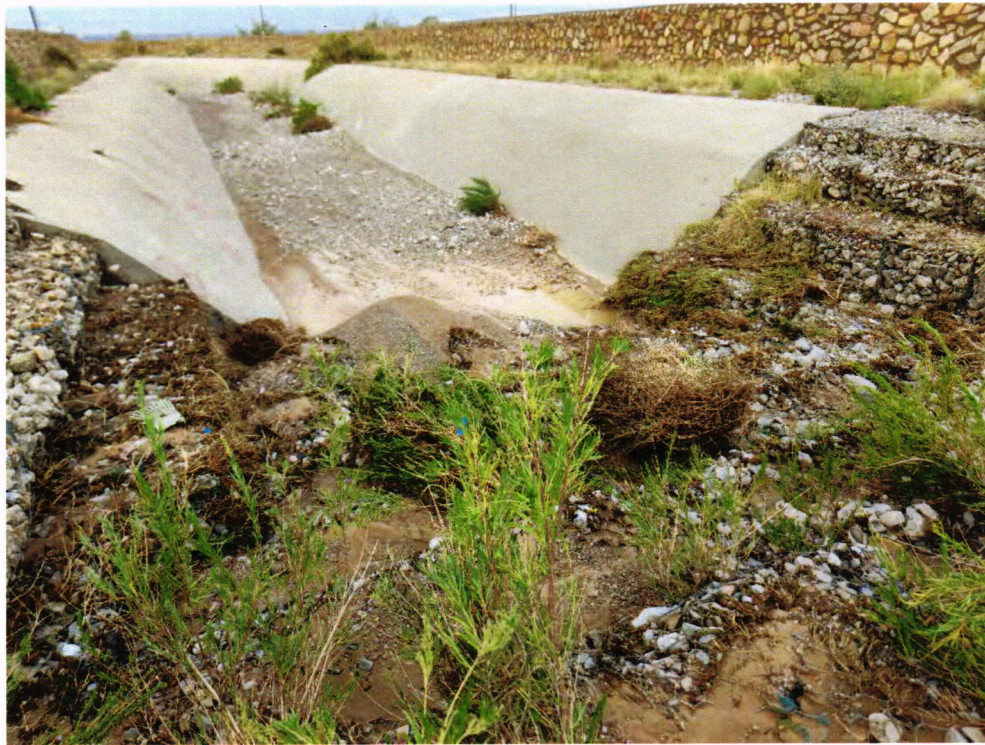
*Photograph 10 – 1-2 MID, standing water (8/18/2022).*

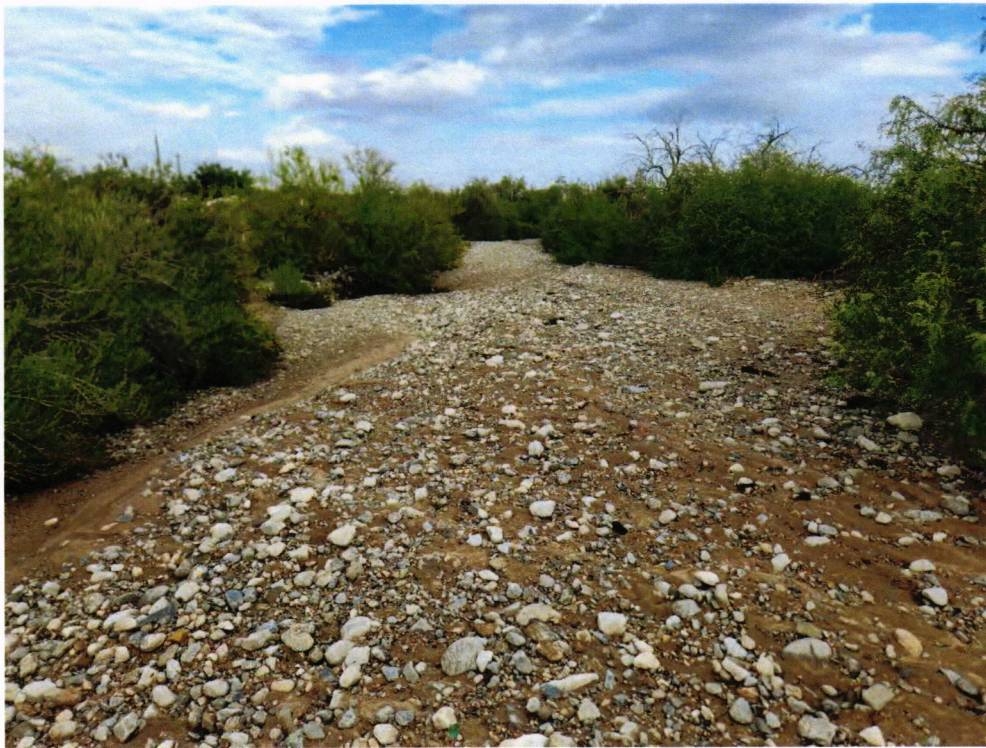
*Photograph 11 – 1-3 MID, moist, no standing water (8/18/2022).*

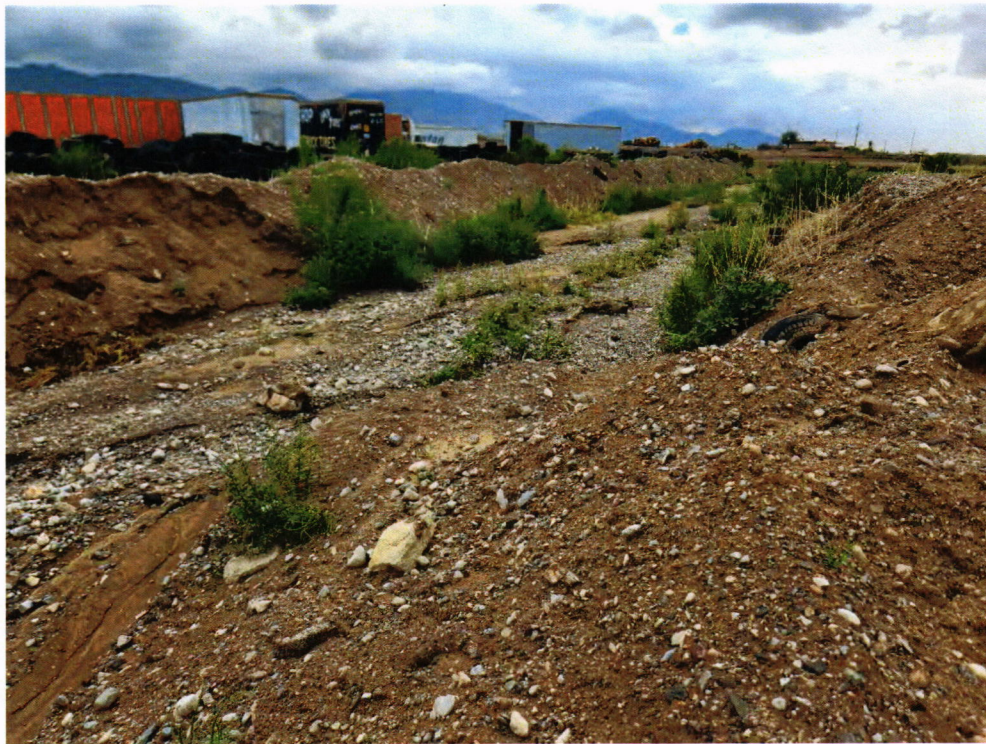
*Photograph 12 – 1-4 MID moist, no standing water, within an active construction site (8/18/2022).*

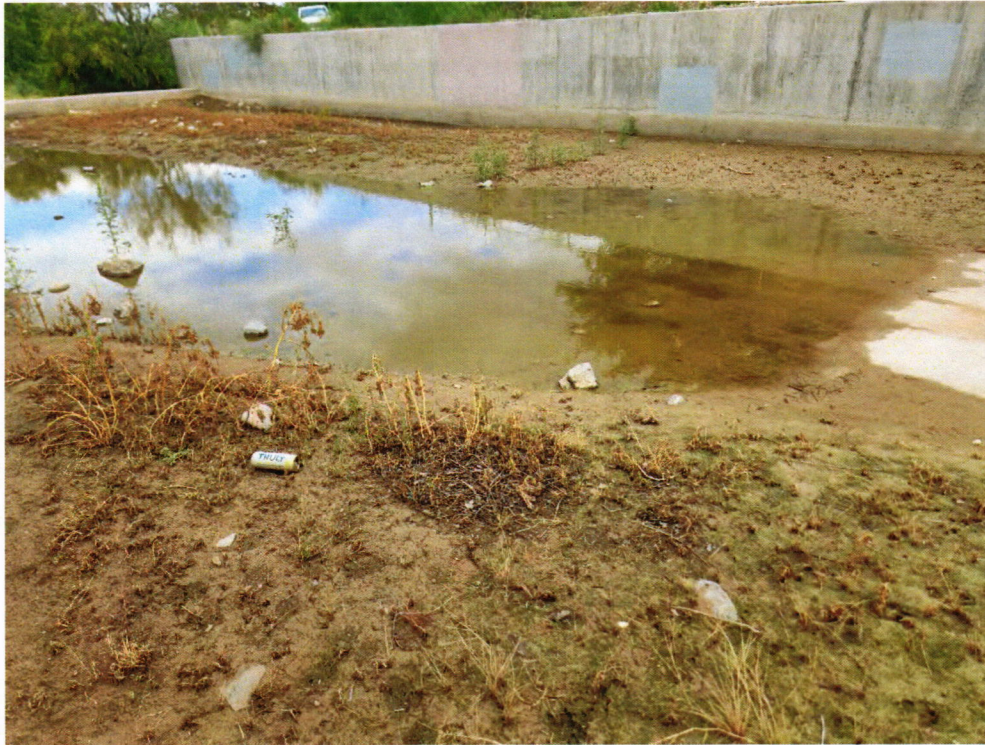
*Photograph 13 – 1-5 MID, standing water (8/18/2022).*

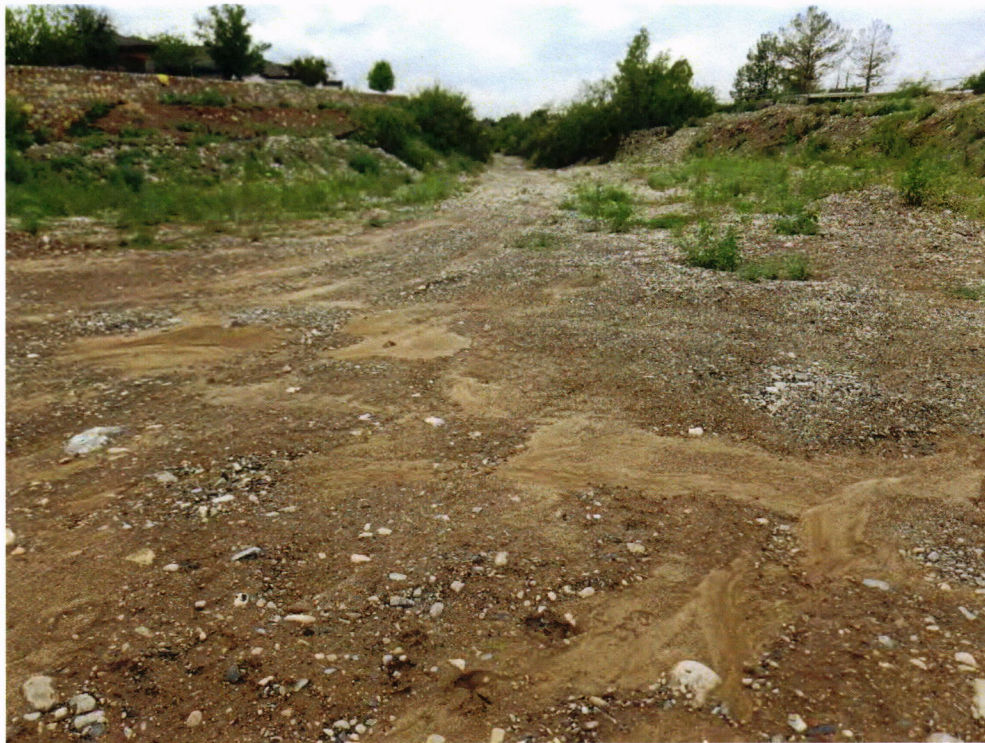
*Photograph 14 – 1-6 MID, moist, no standing water 8/18/22. SMA collected a sample nearby on 8/23/22.*

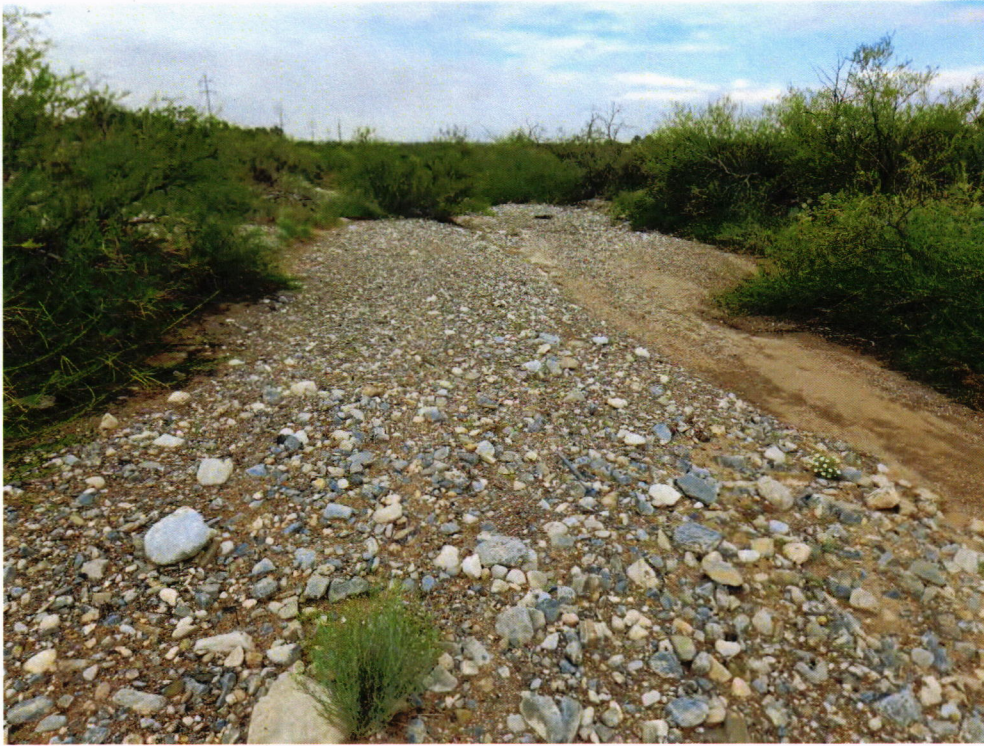
*Photograph 15 – 1-7 MID, moist no standing water (8/18/2022).*
