# El Paso County Stormwater Master Plan

February 2021

El Paso Water  
1154 Hawkins Boulevard  
El Paso, Texas 79961

El Paso County  
500 E. San Antonio  
El Paso, TX 79901

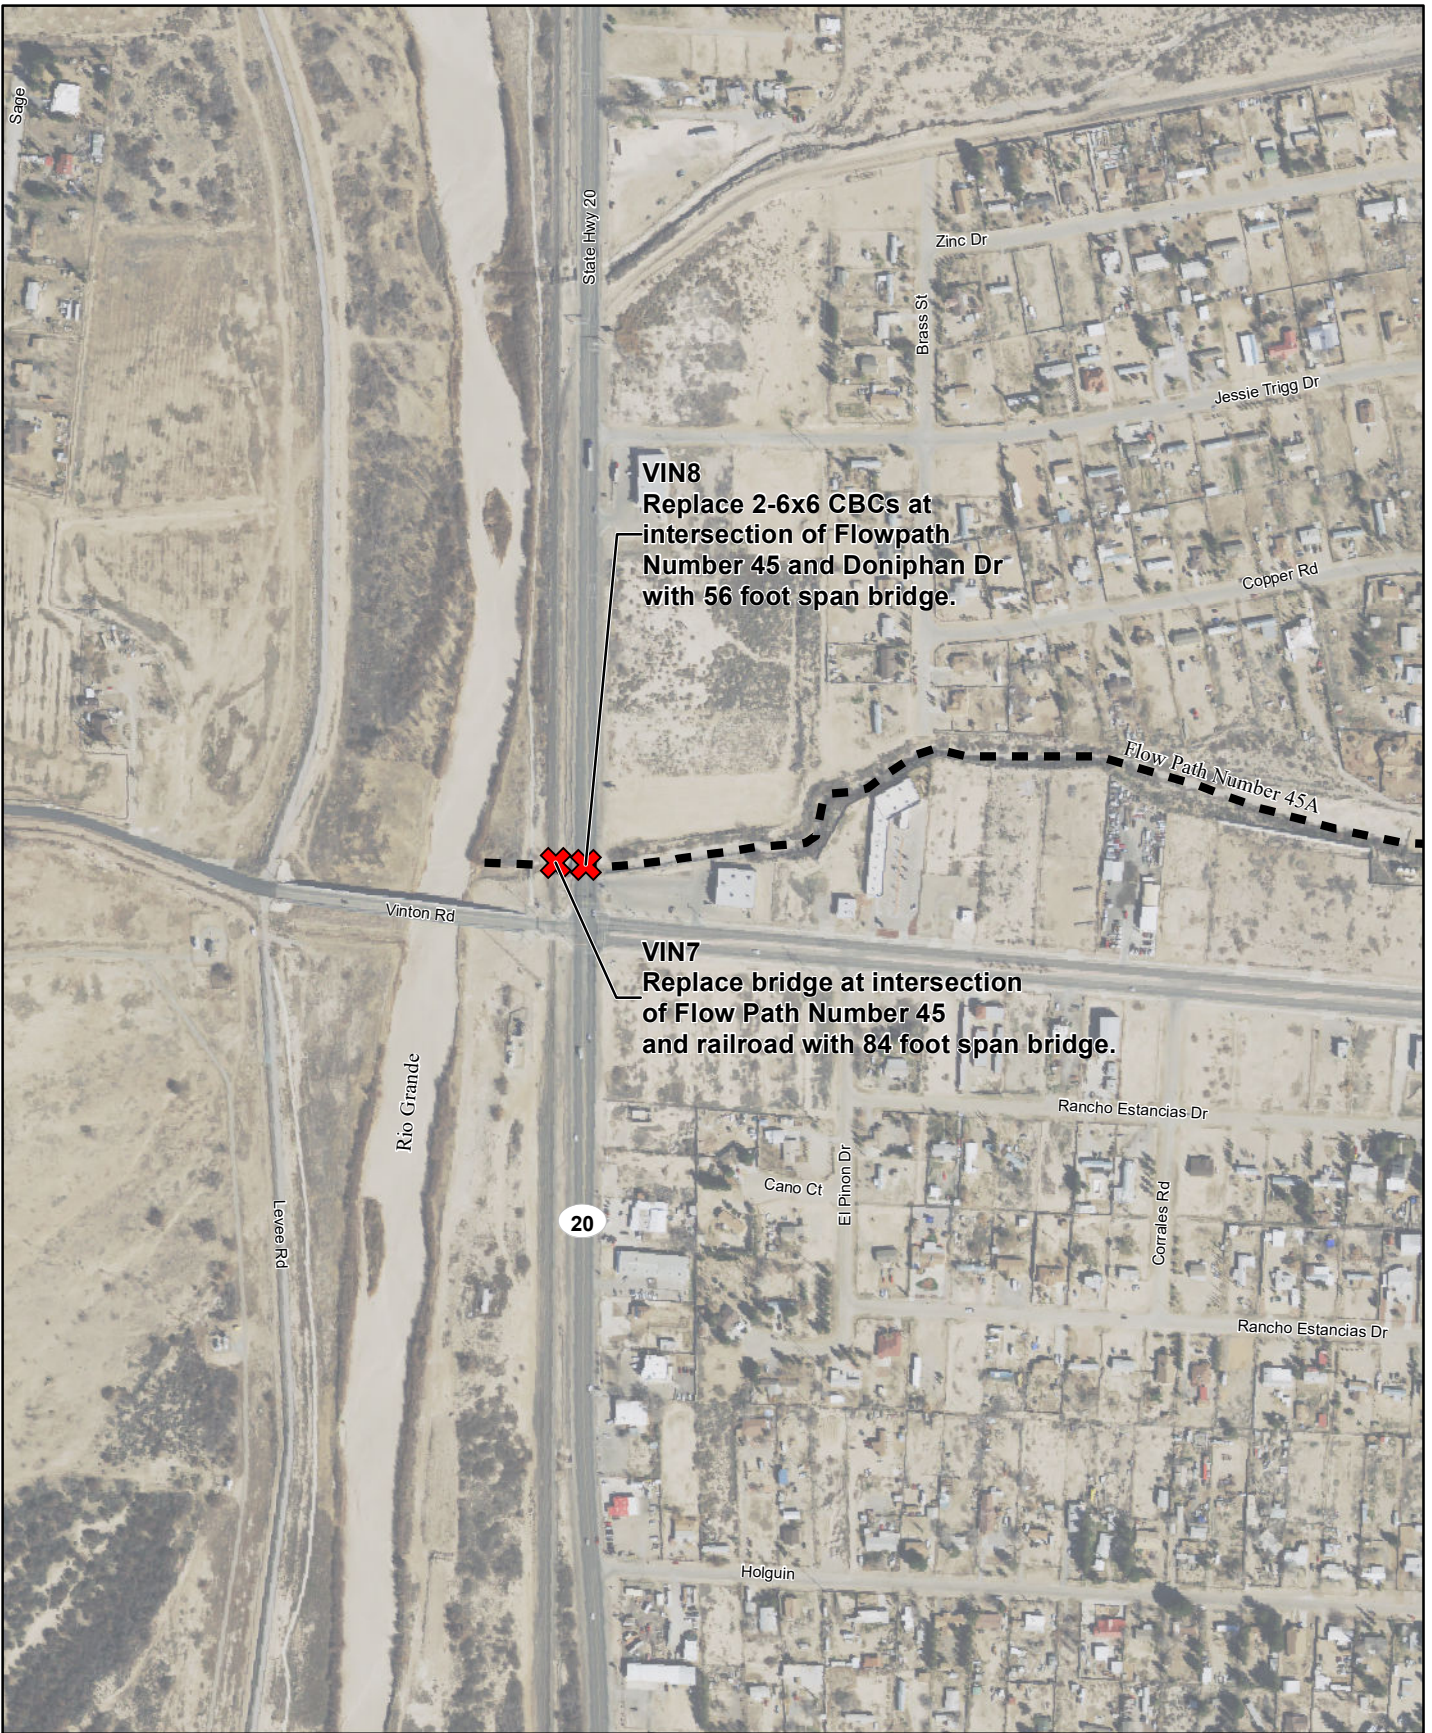
**VIN8**  
 Replace 2-6x6 CBCs at  
 intersection of Flowpath  
 Number 45 and Doniphan Dr  
 with 56 foot span bridge.

**VIN7**  
 Replace bridge at intersection  
 of Flow Path Number 45  
 and railroad with 84 foot span bridge.

The bridge at the intersection of Flow Path Number 45 and The Railroad was reported to have insufficient capacity. Based on inspection and hydraulic analysis, the bridge does not have sufficient capacity to convey the 100-year flood through the crossing. There are current plans to replace the existing bridge with a control structure that is being sized to match the capacity of the Doniphan Rd bridge (VIN8), which also has insufficient capacity.

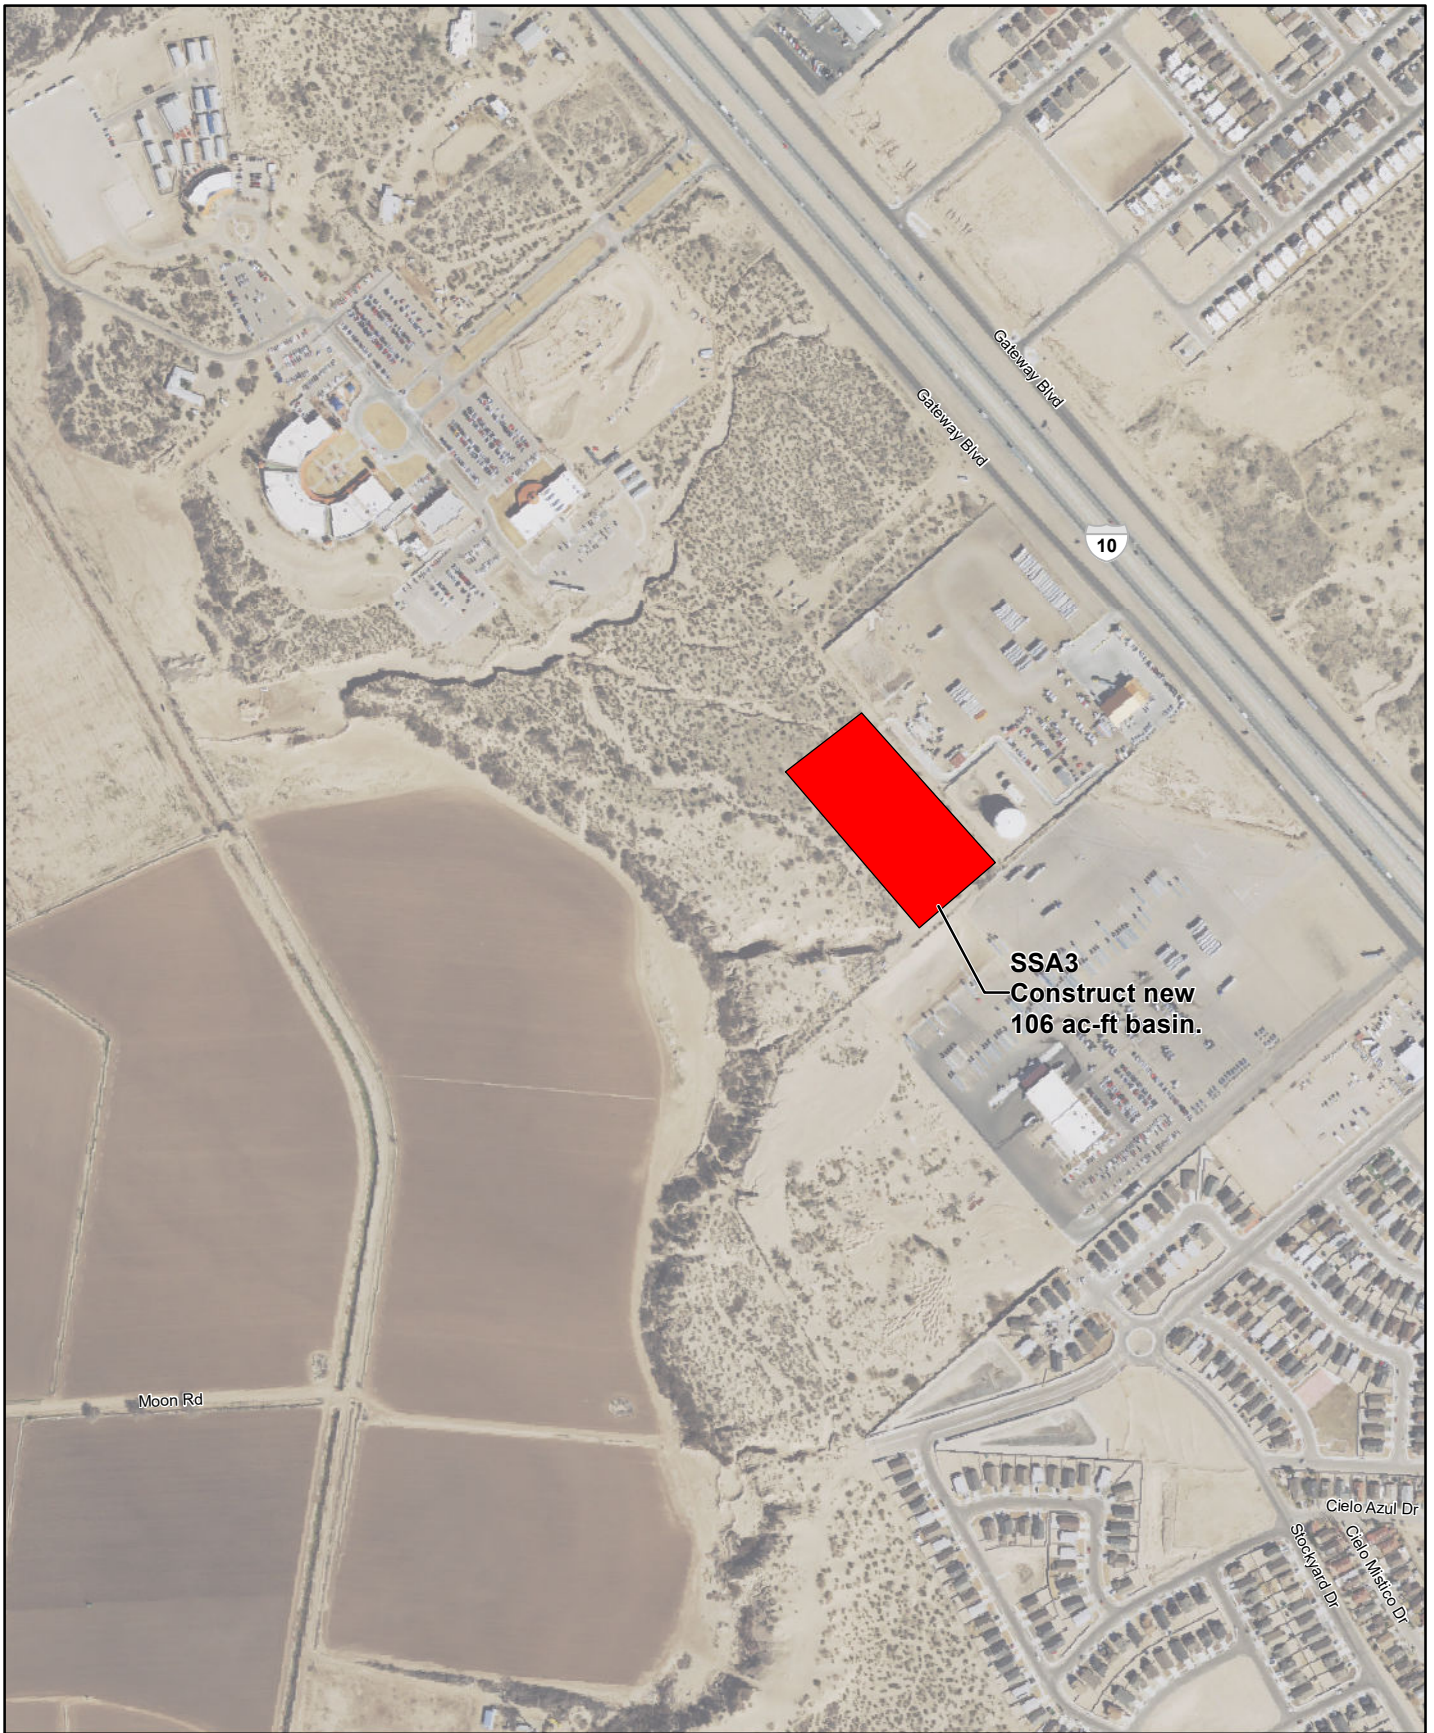
SSA3  
Construct new  
106 ac-ft basin.

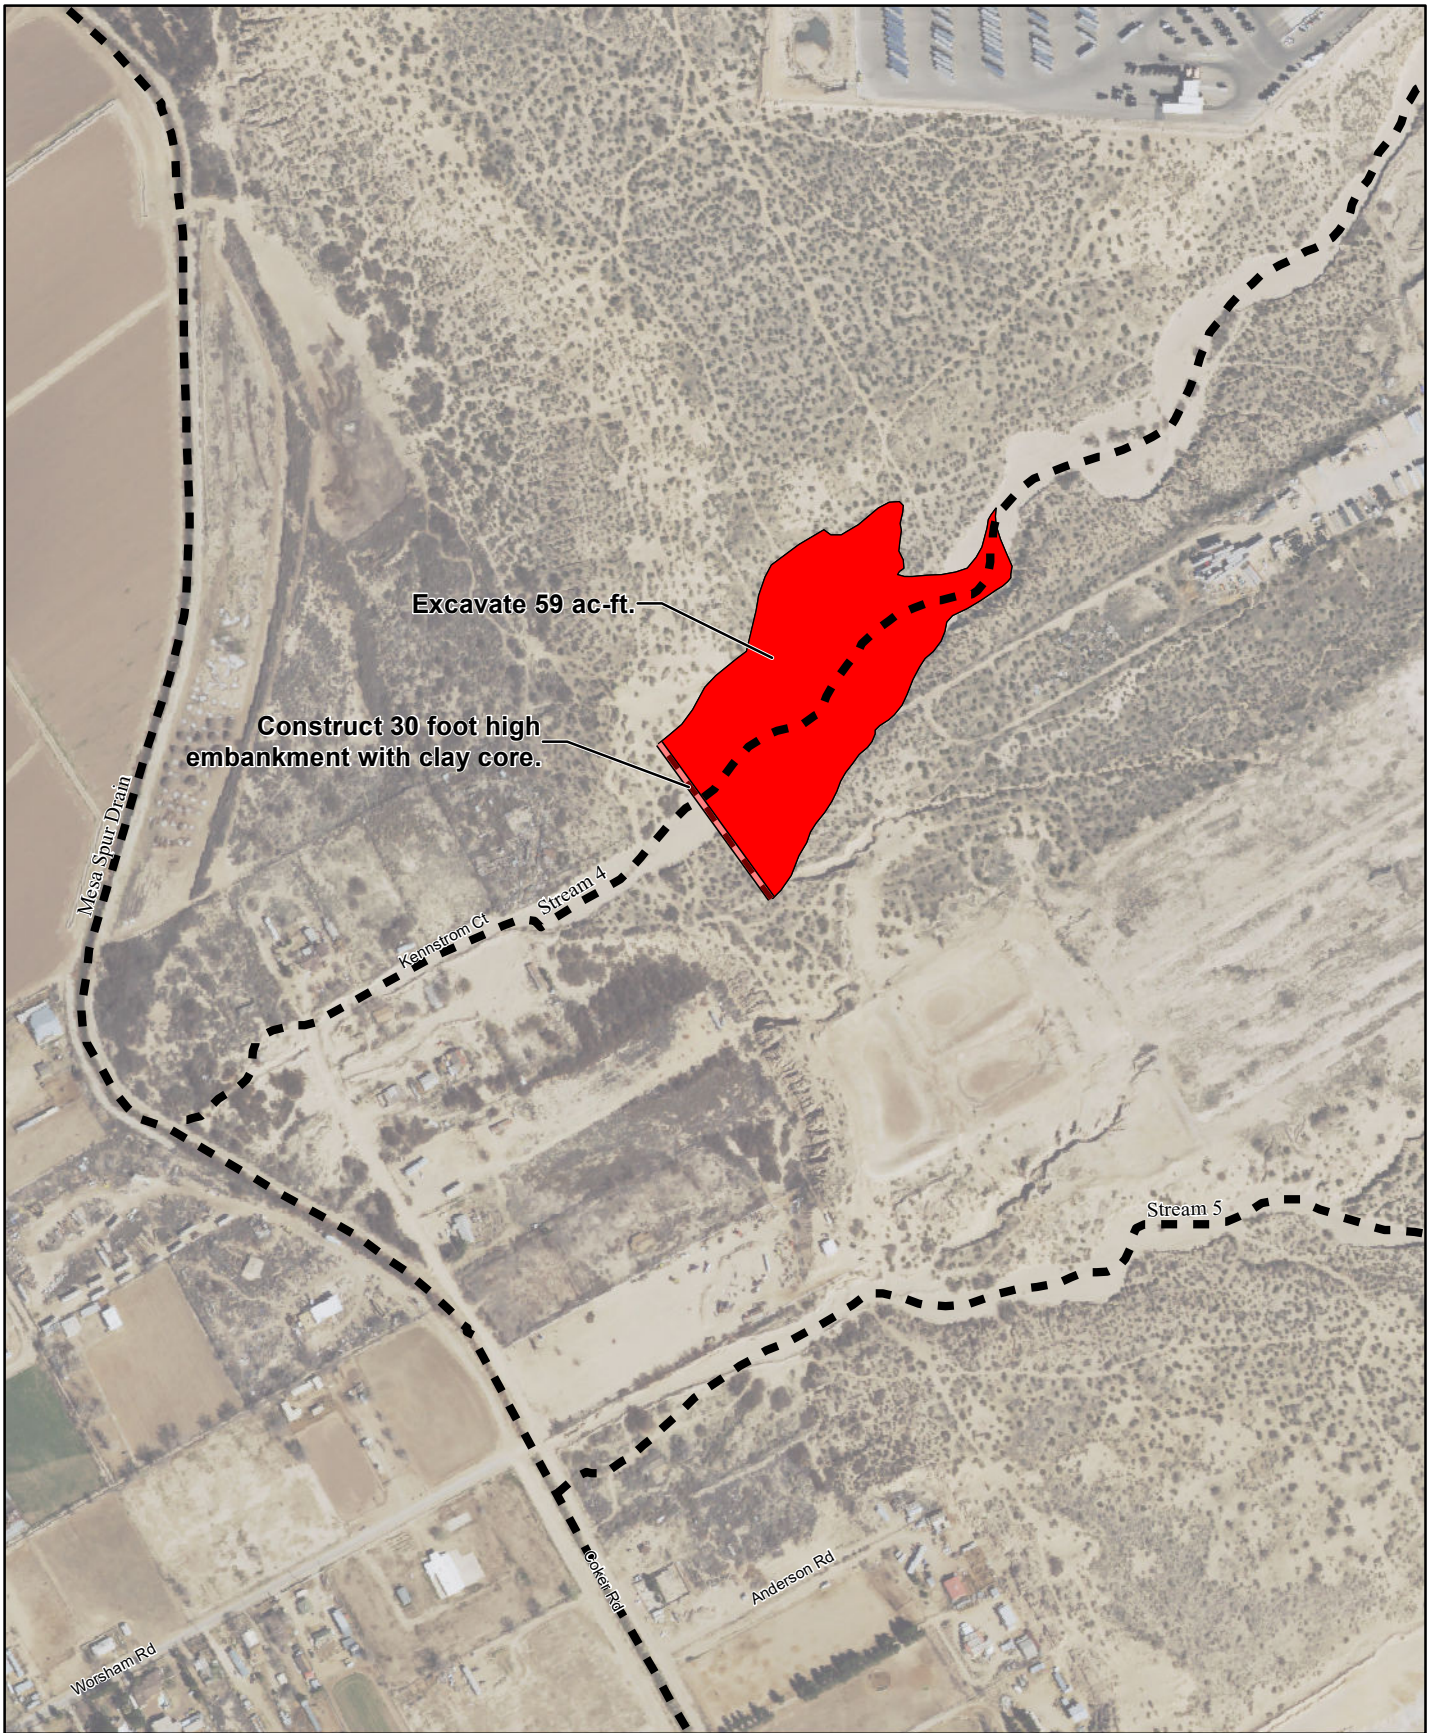
Figure 6-12

These proposed improvements require that the basin be acquired by El Paso County before they can be made. These improvements are also predicated on the assumption that documents can be provided that demonstrate that the original embankment was properly engineered, constructed, and approved. These proposed improvements are shown on Figure 6-12.

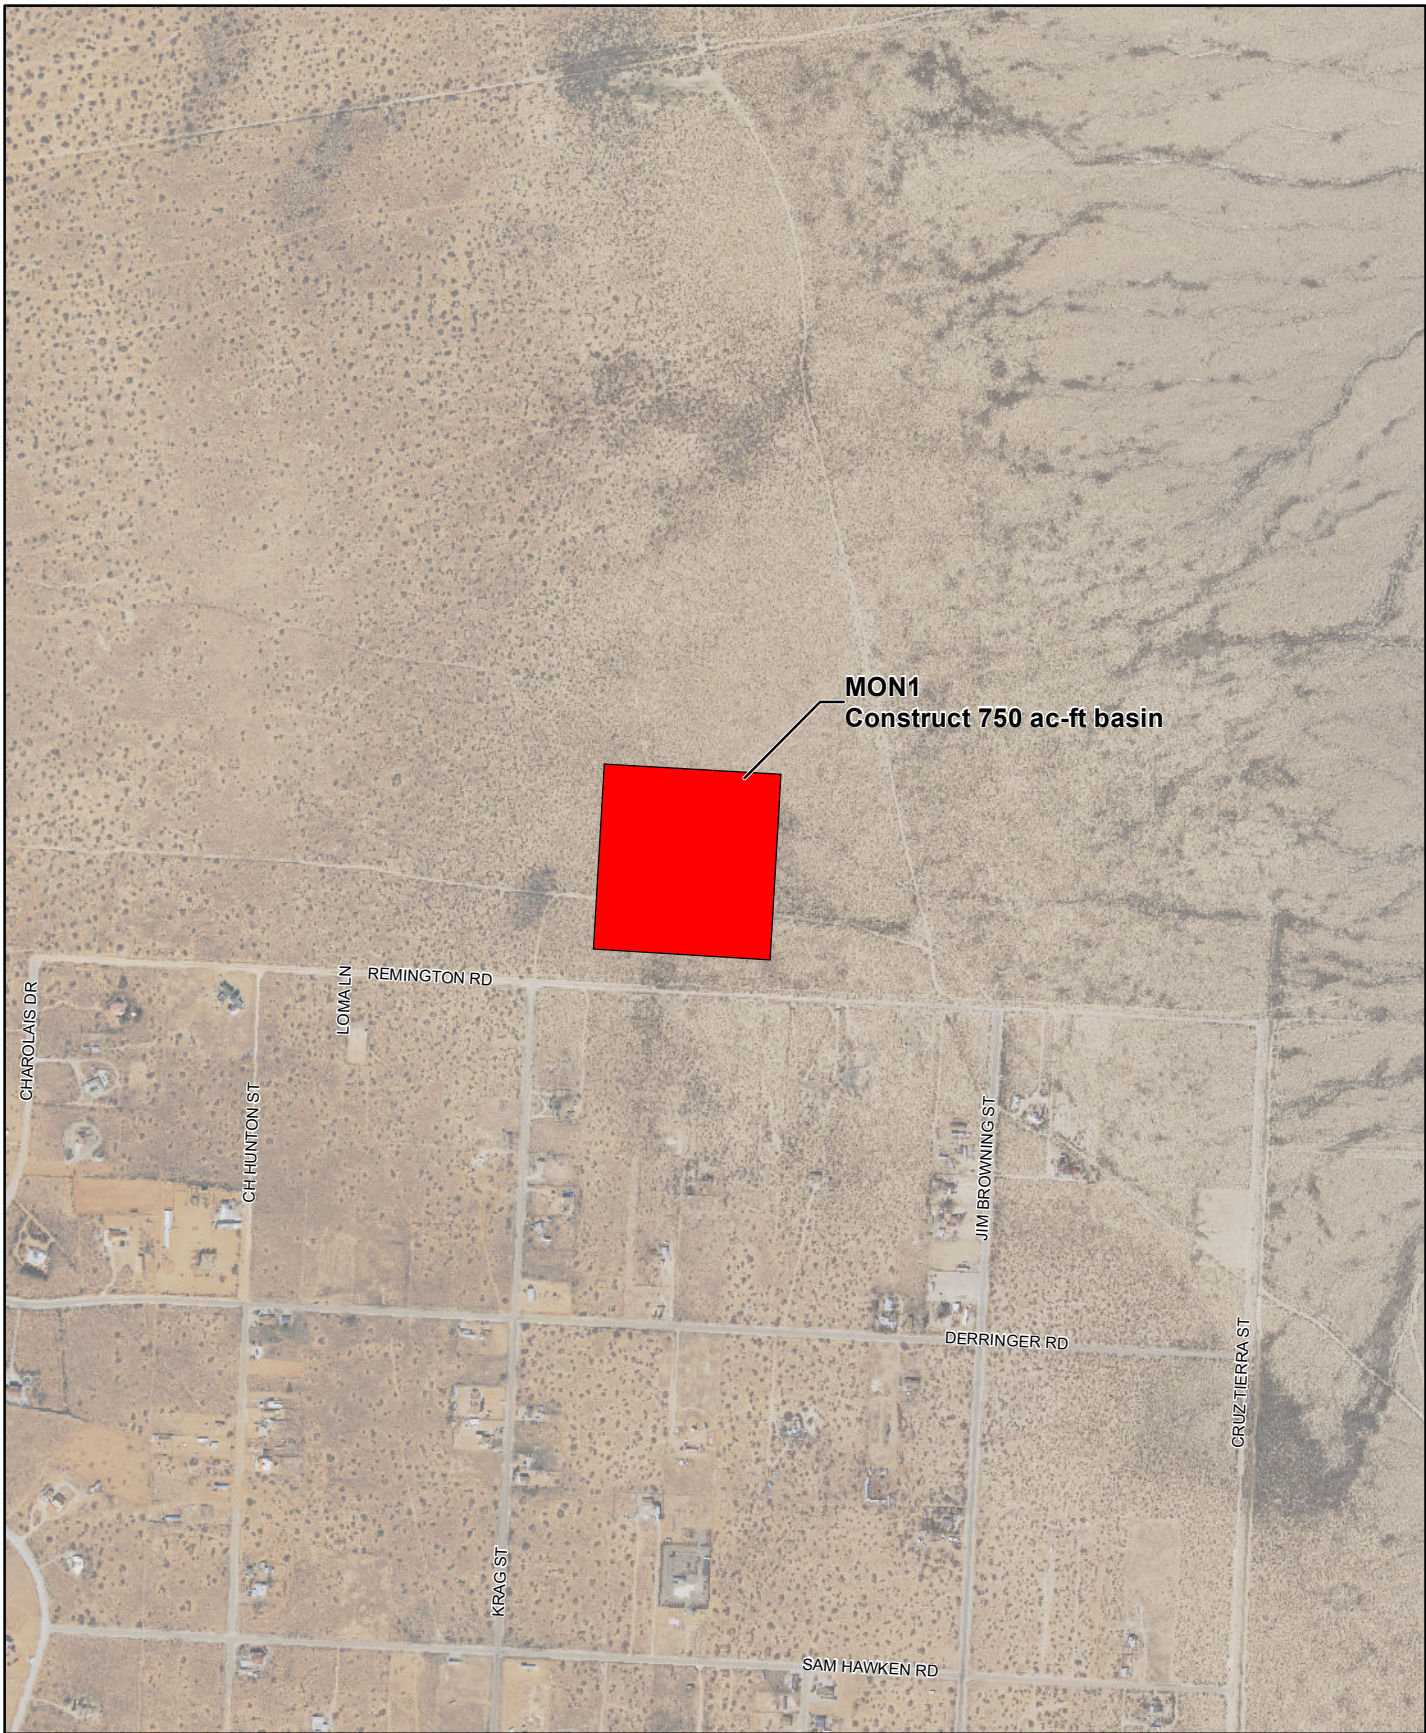
Figure 6-26

This project involves constructing a retention basin on currently vacant land at the confluence of Tornillo Handle Channel 1 and Tornillo Handle Channel 2. The proposed embankment is approximately 10 feet tall. The proposed basin requires approximately 8 acre-feet of excavation for flood and sediment pool storage. The outlet structure for this basin consists of a 2-foot by 2-foot CBC. The purpose of the basin is to retain flows and sediment conveyed by the Tornillo Handle Channel 1 and Tornillo Handle Channel 2 and release them at a controlled rate. These proposed improvements are shown on Figure 6-26.

This project involves the improvement of the existing embankment of the south bank of Tornillo Handle Channel 1. The project does not include any change to the configuration of the channel. The channel bank improvement consists of 1,650 feet of 3 to 1 side slope riprap reinforcement along the south bank. If the retention basin discussed in TOR4 has not been constructed prior to this project, it should be constructed as part of this project. These proposed improvements are shown on Figure 6-26.

This project involves replacing the existing two 36-inch pipes at the intersection of Tornillo Handle Channel 2 and OT Smith Road with two 5-foot by 2-foot CBCs. This culvert size will provide sufficient capacity for the 100-year flood to be conveyed through the crossing. This proposed improvement is shown on Figure 6-26.

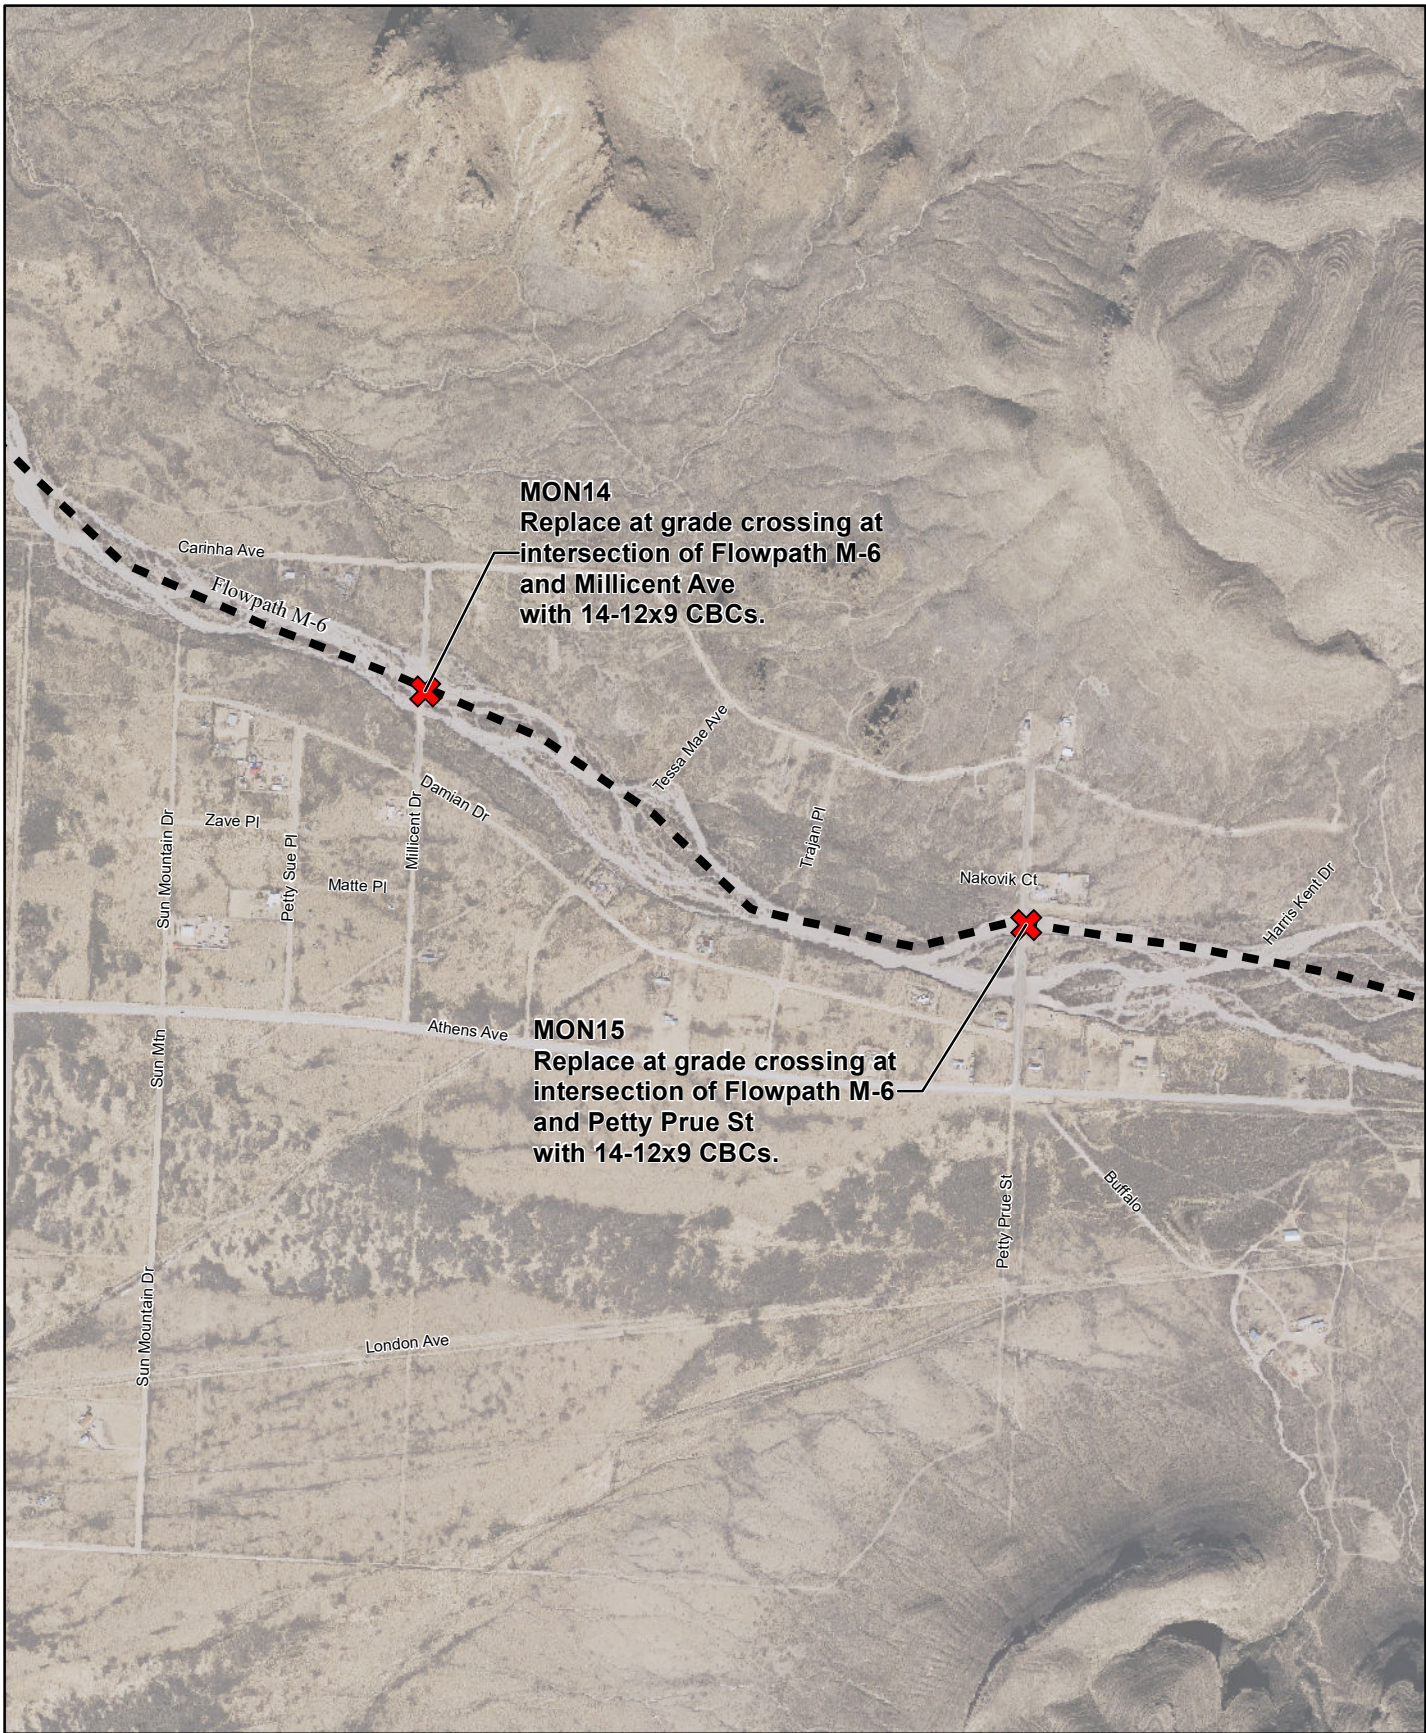
**MON14**  
 Replace at grade crossing at  
 intersection of Flowpath M-6  
 and Millicent Ave  
 with 14-12x9 CBCs.

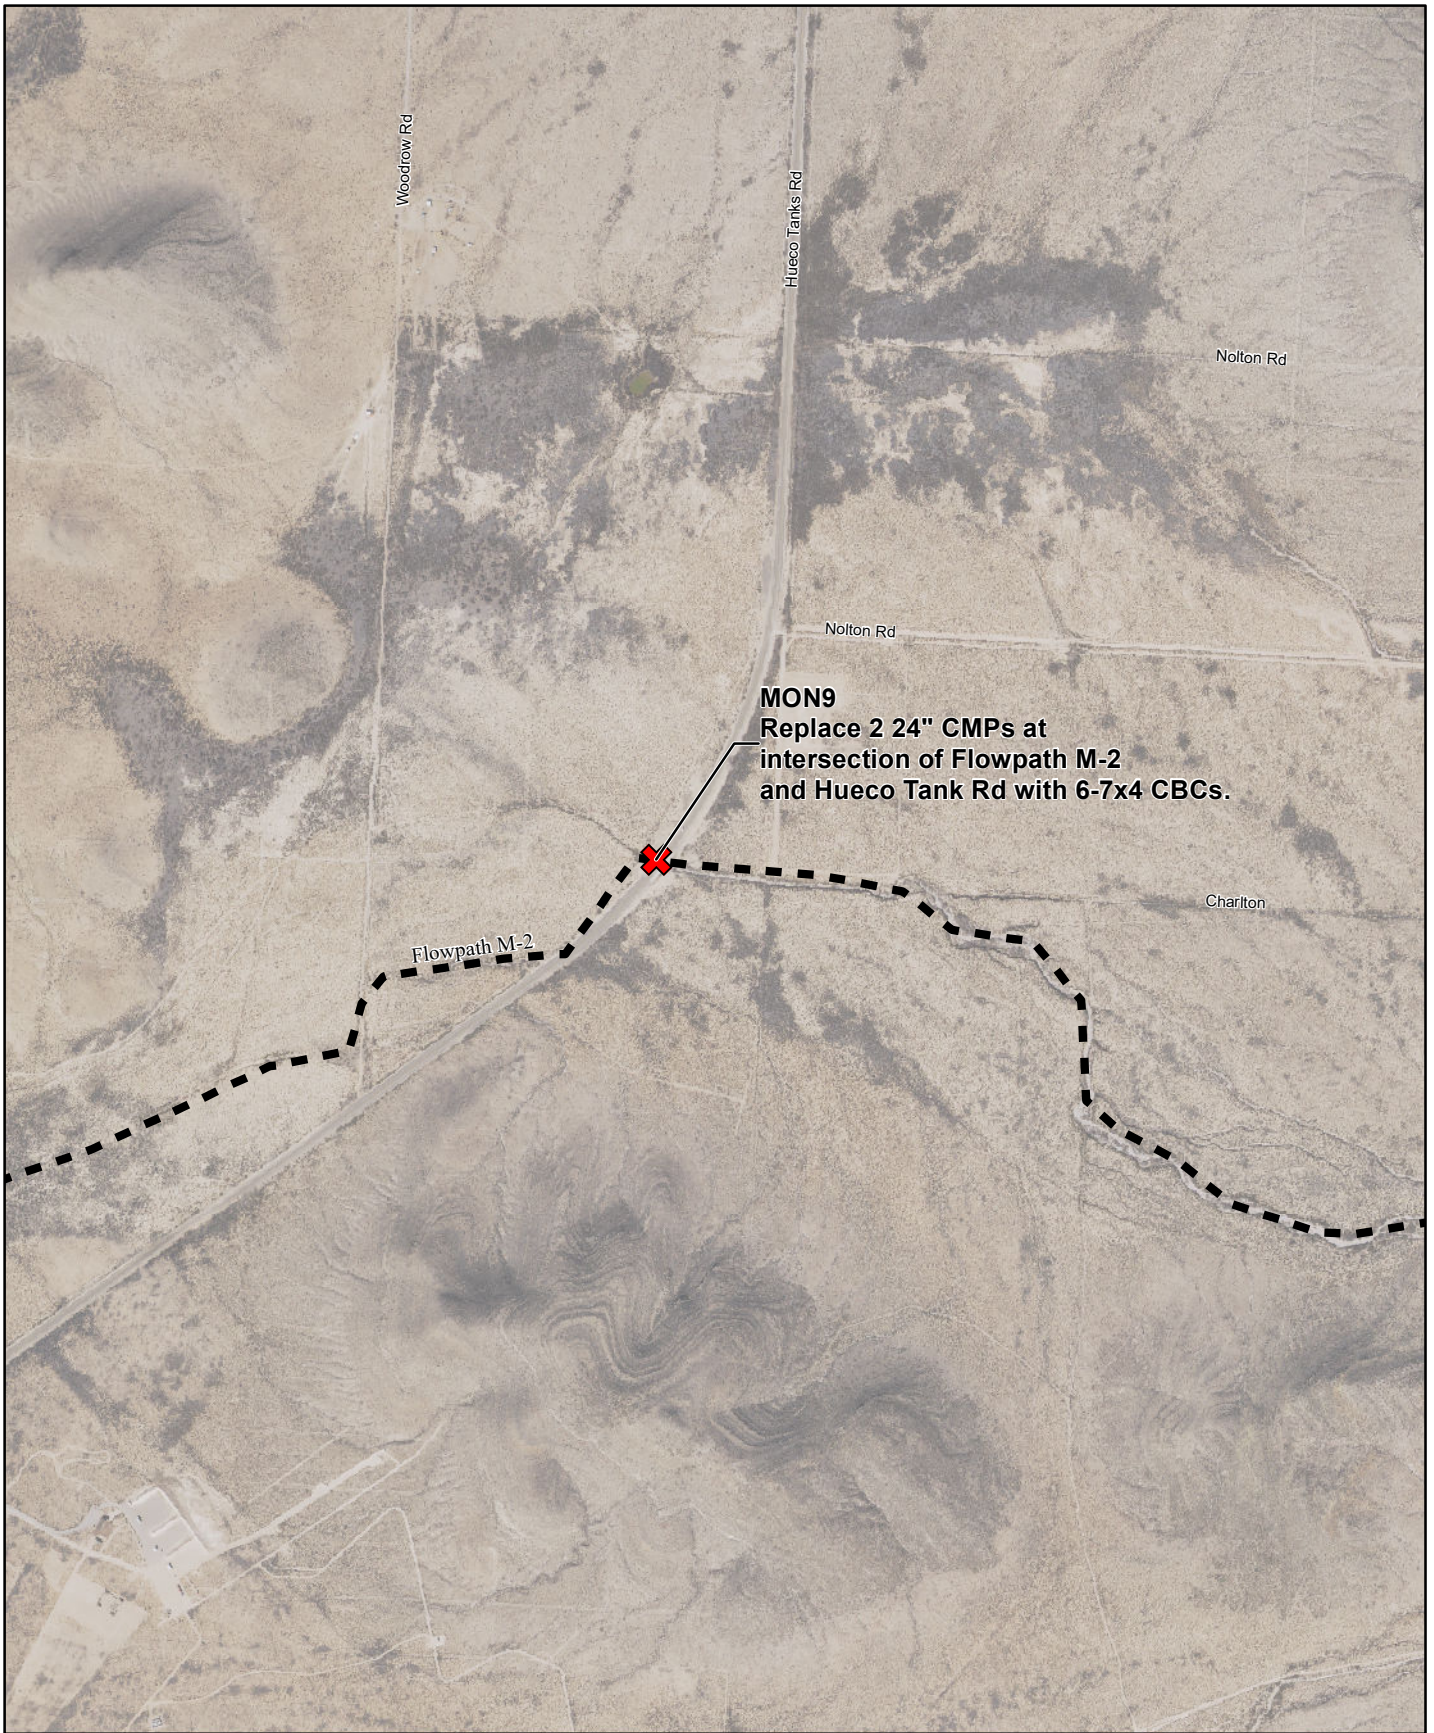
**MON9**  
 Replace 2 24" CMPs at  
 intersection of Flowpath M-2  
 and Hueco Tank Rd with 6-7x4 CBCs.
