***Re: Phase II MS4 Annual Report Transmittal for the County of El Paso TPDES Permit Authorization:  
TXR040202***

# Phase II (Small) MS4 Annual Report Form

TPDES General Permit Number TXR040000

Authorization Number: TXR040202

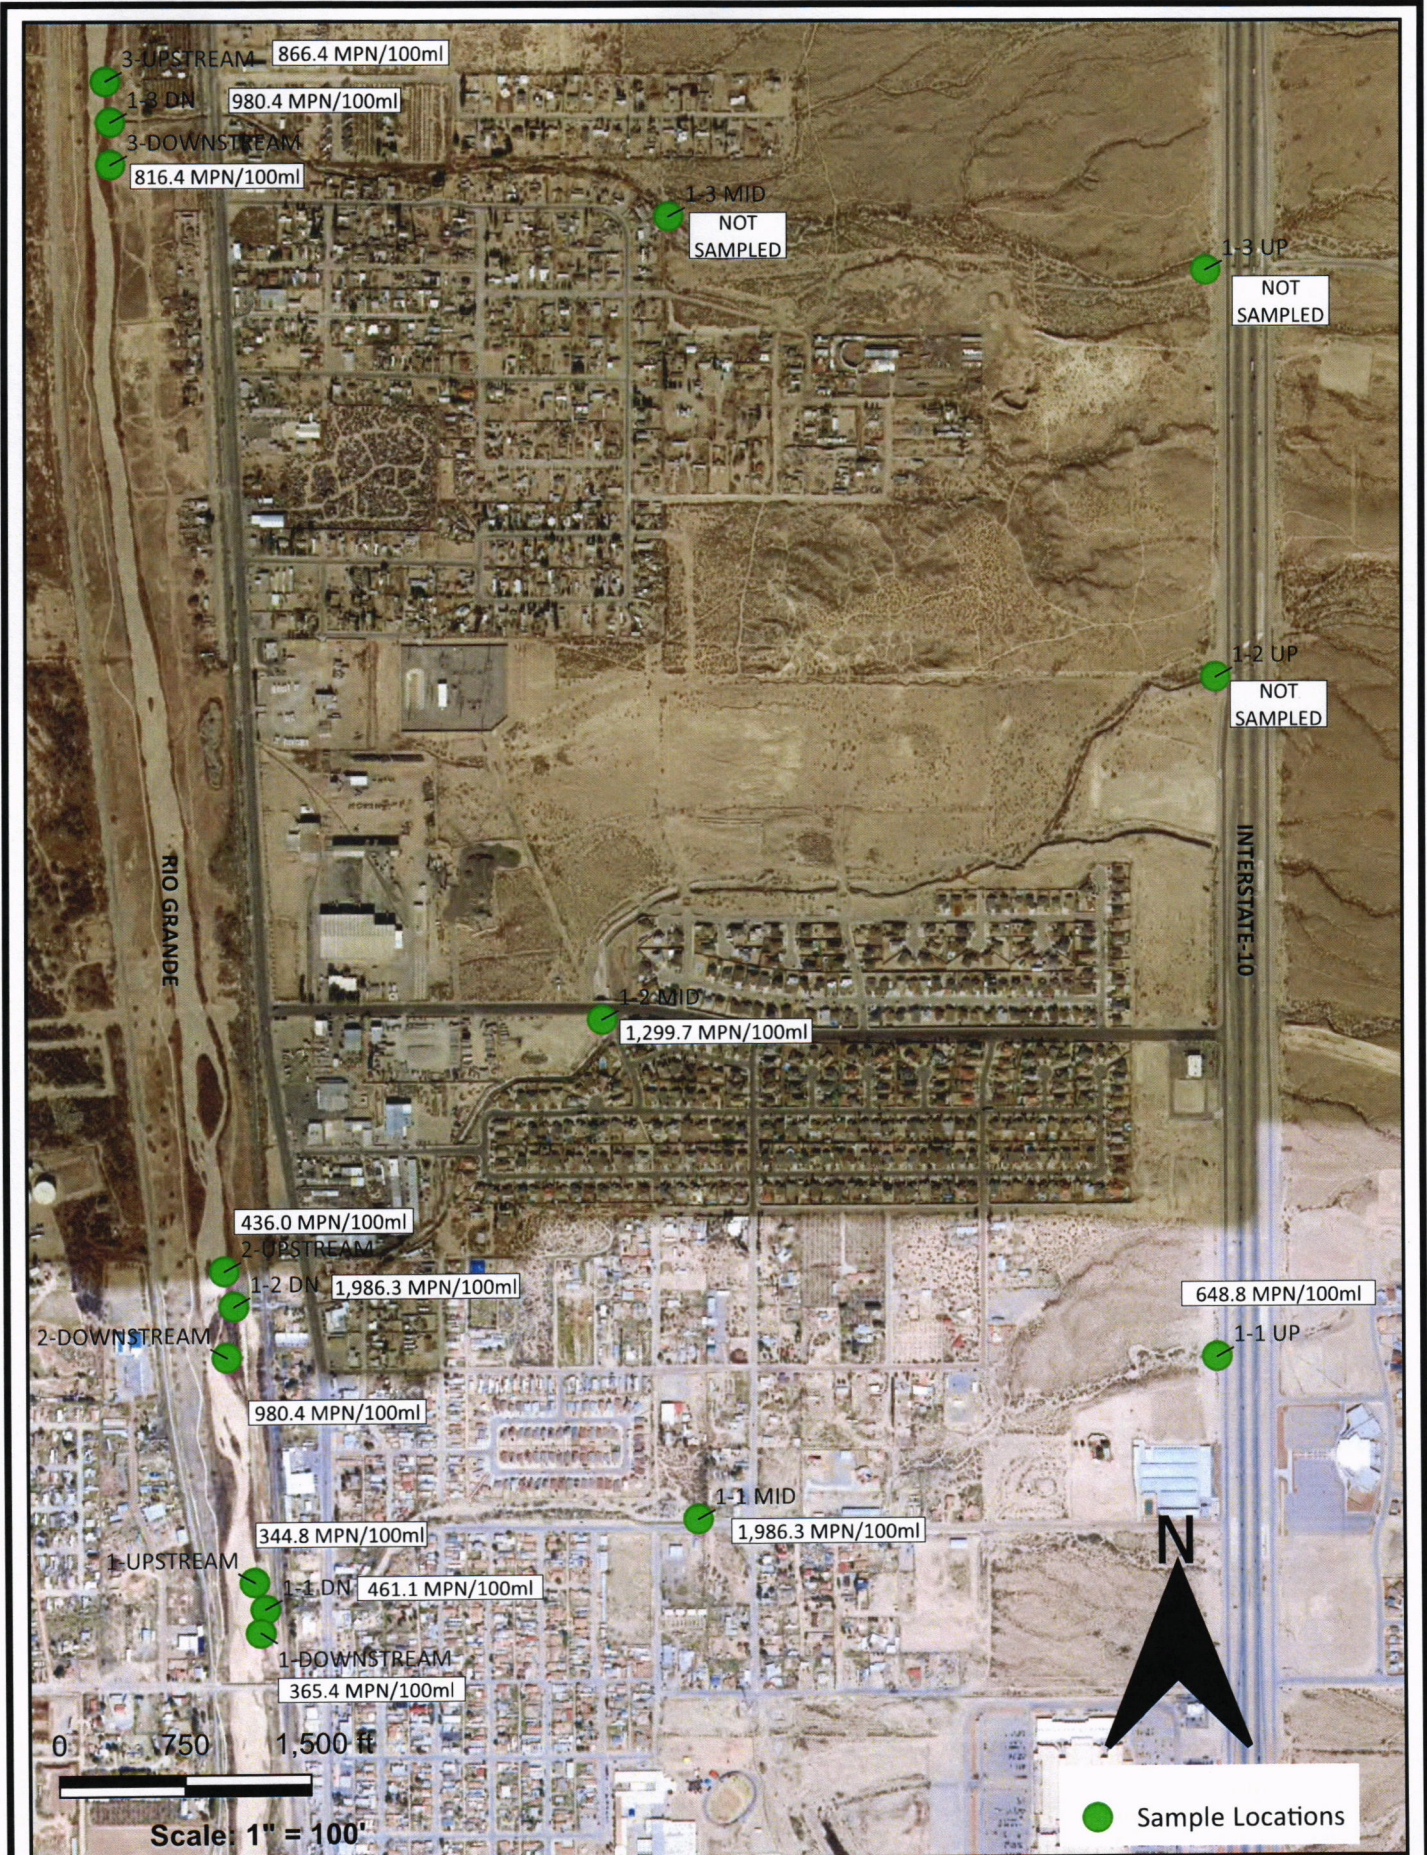
Figure 1

Figures 1 and 2 illustrate Arroyos 1-3 and Arroyos 4-7, respectively, with sampling locations and analytical results.

Arroyo 1-3  
MS4 Outfall Sampling  
El Paso, Texas

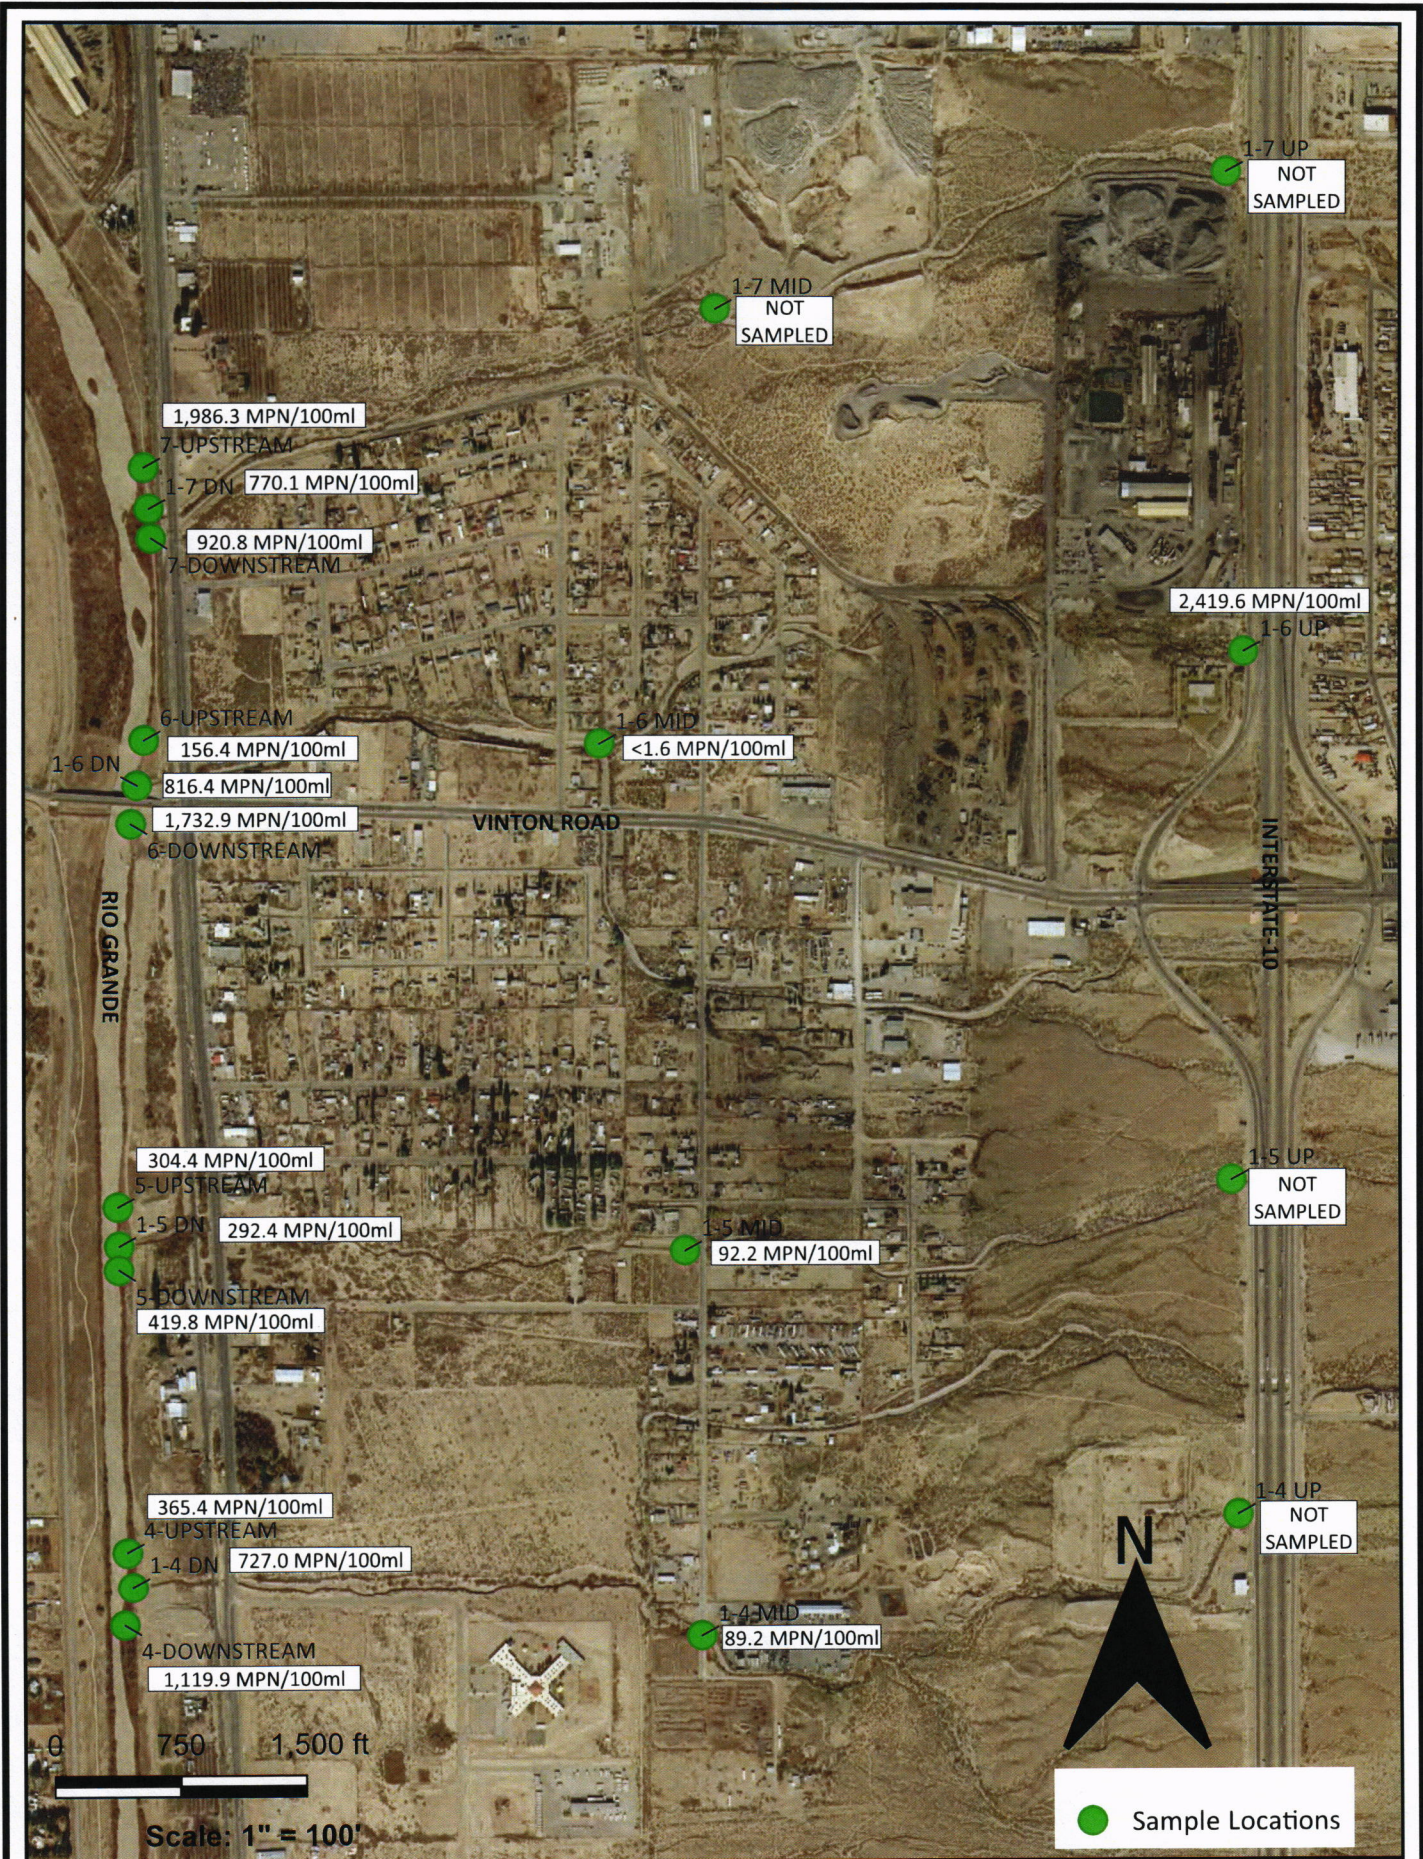
Arroyo 4-7  
MS4 Outfall Sampling  
El Paso, Texas
