El Paso County Stormwater Master Plan

August 2010

URS Corporation
Austin, TX, Albuquerque, NM

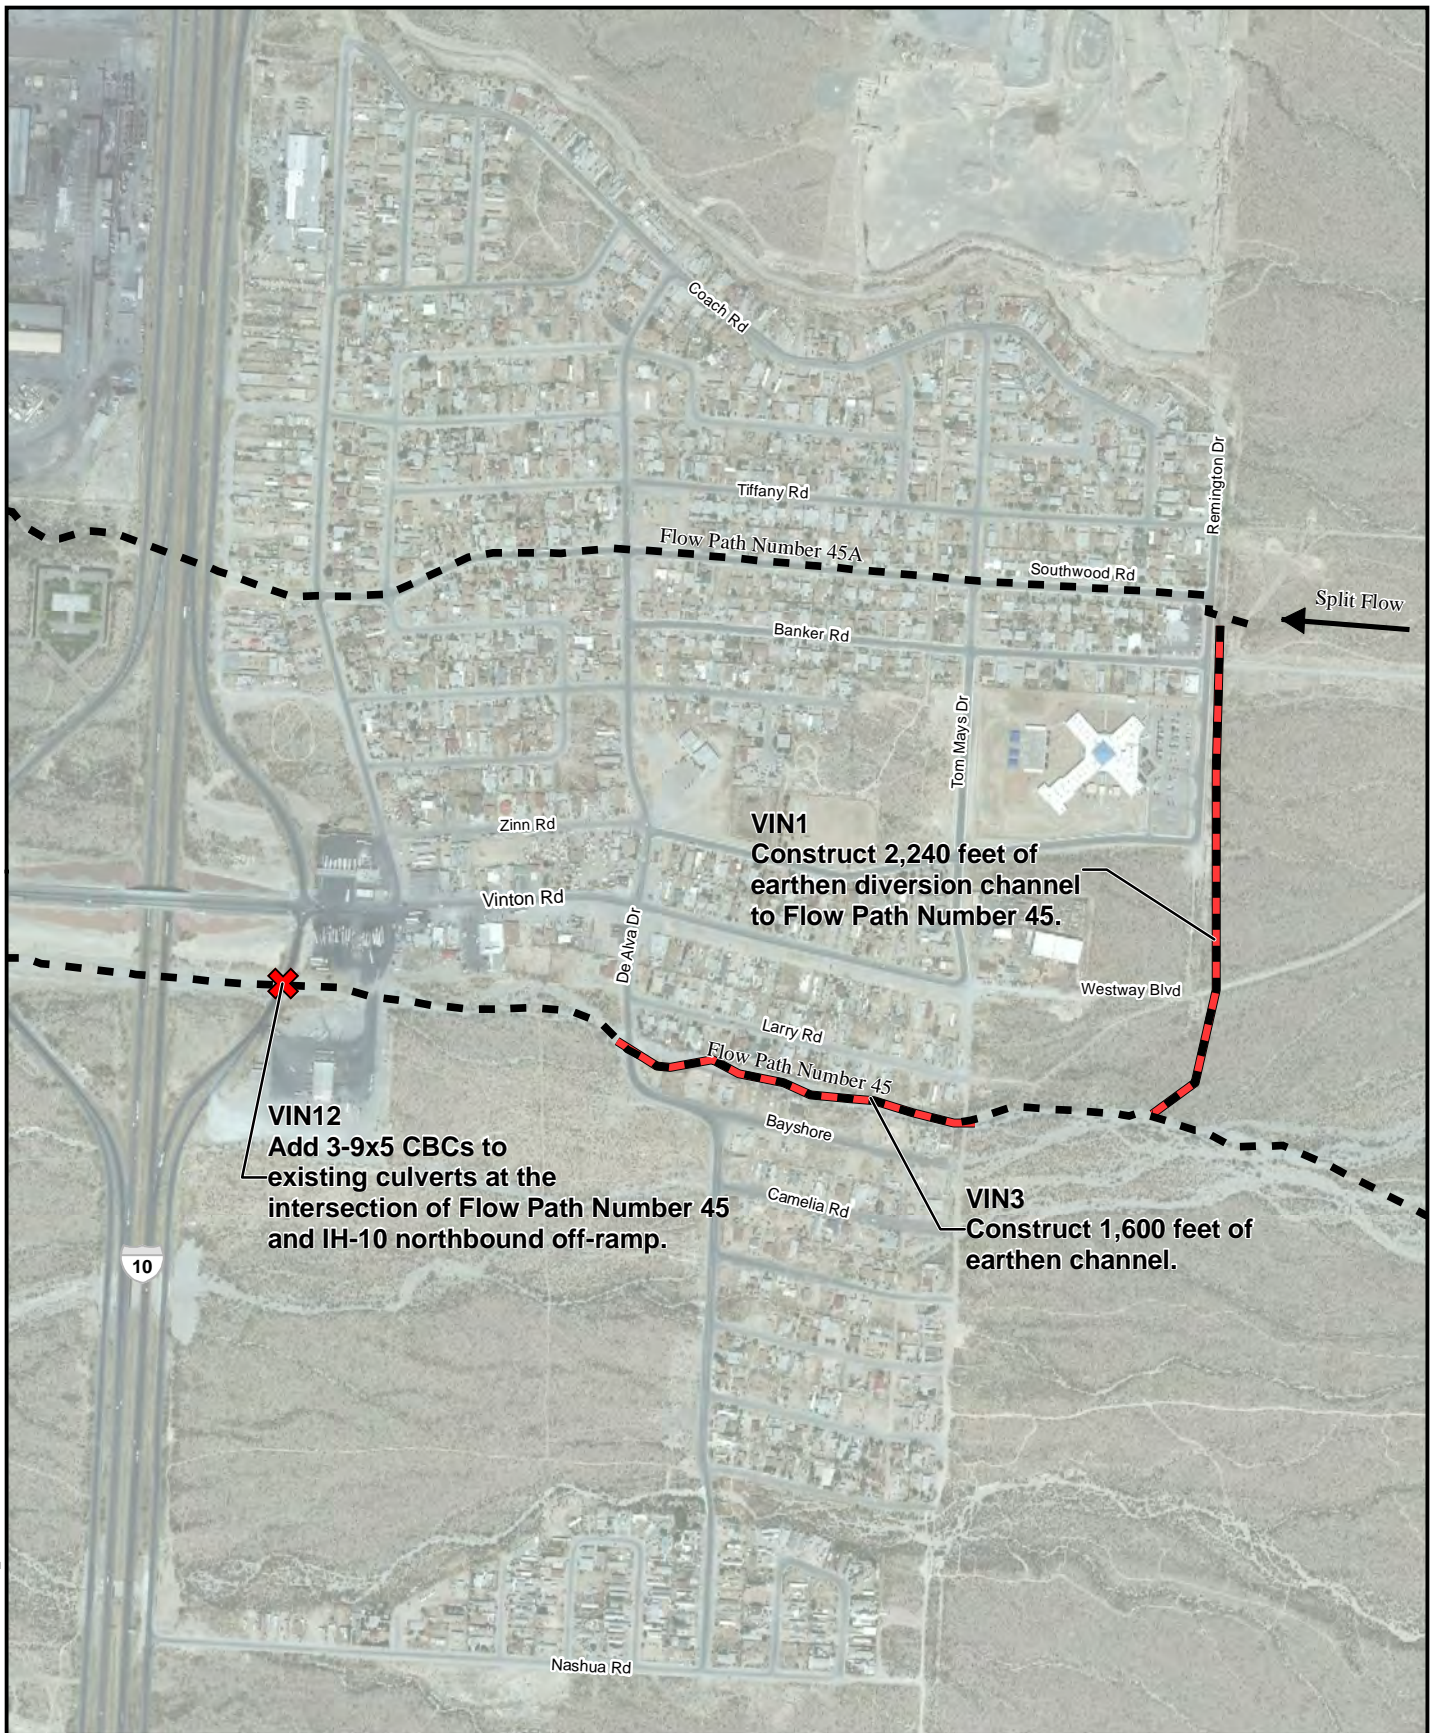
VIN1
Construct 2,240 feet of earthen diversion channel to Flow Path Number 45.

VIN12
Add 3-9x5 CBCs to existing culverts at the intersection of Flow Path Number 45 and IH-10 northbound off-ramp.

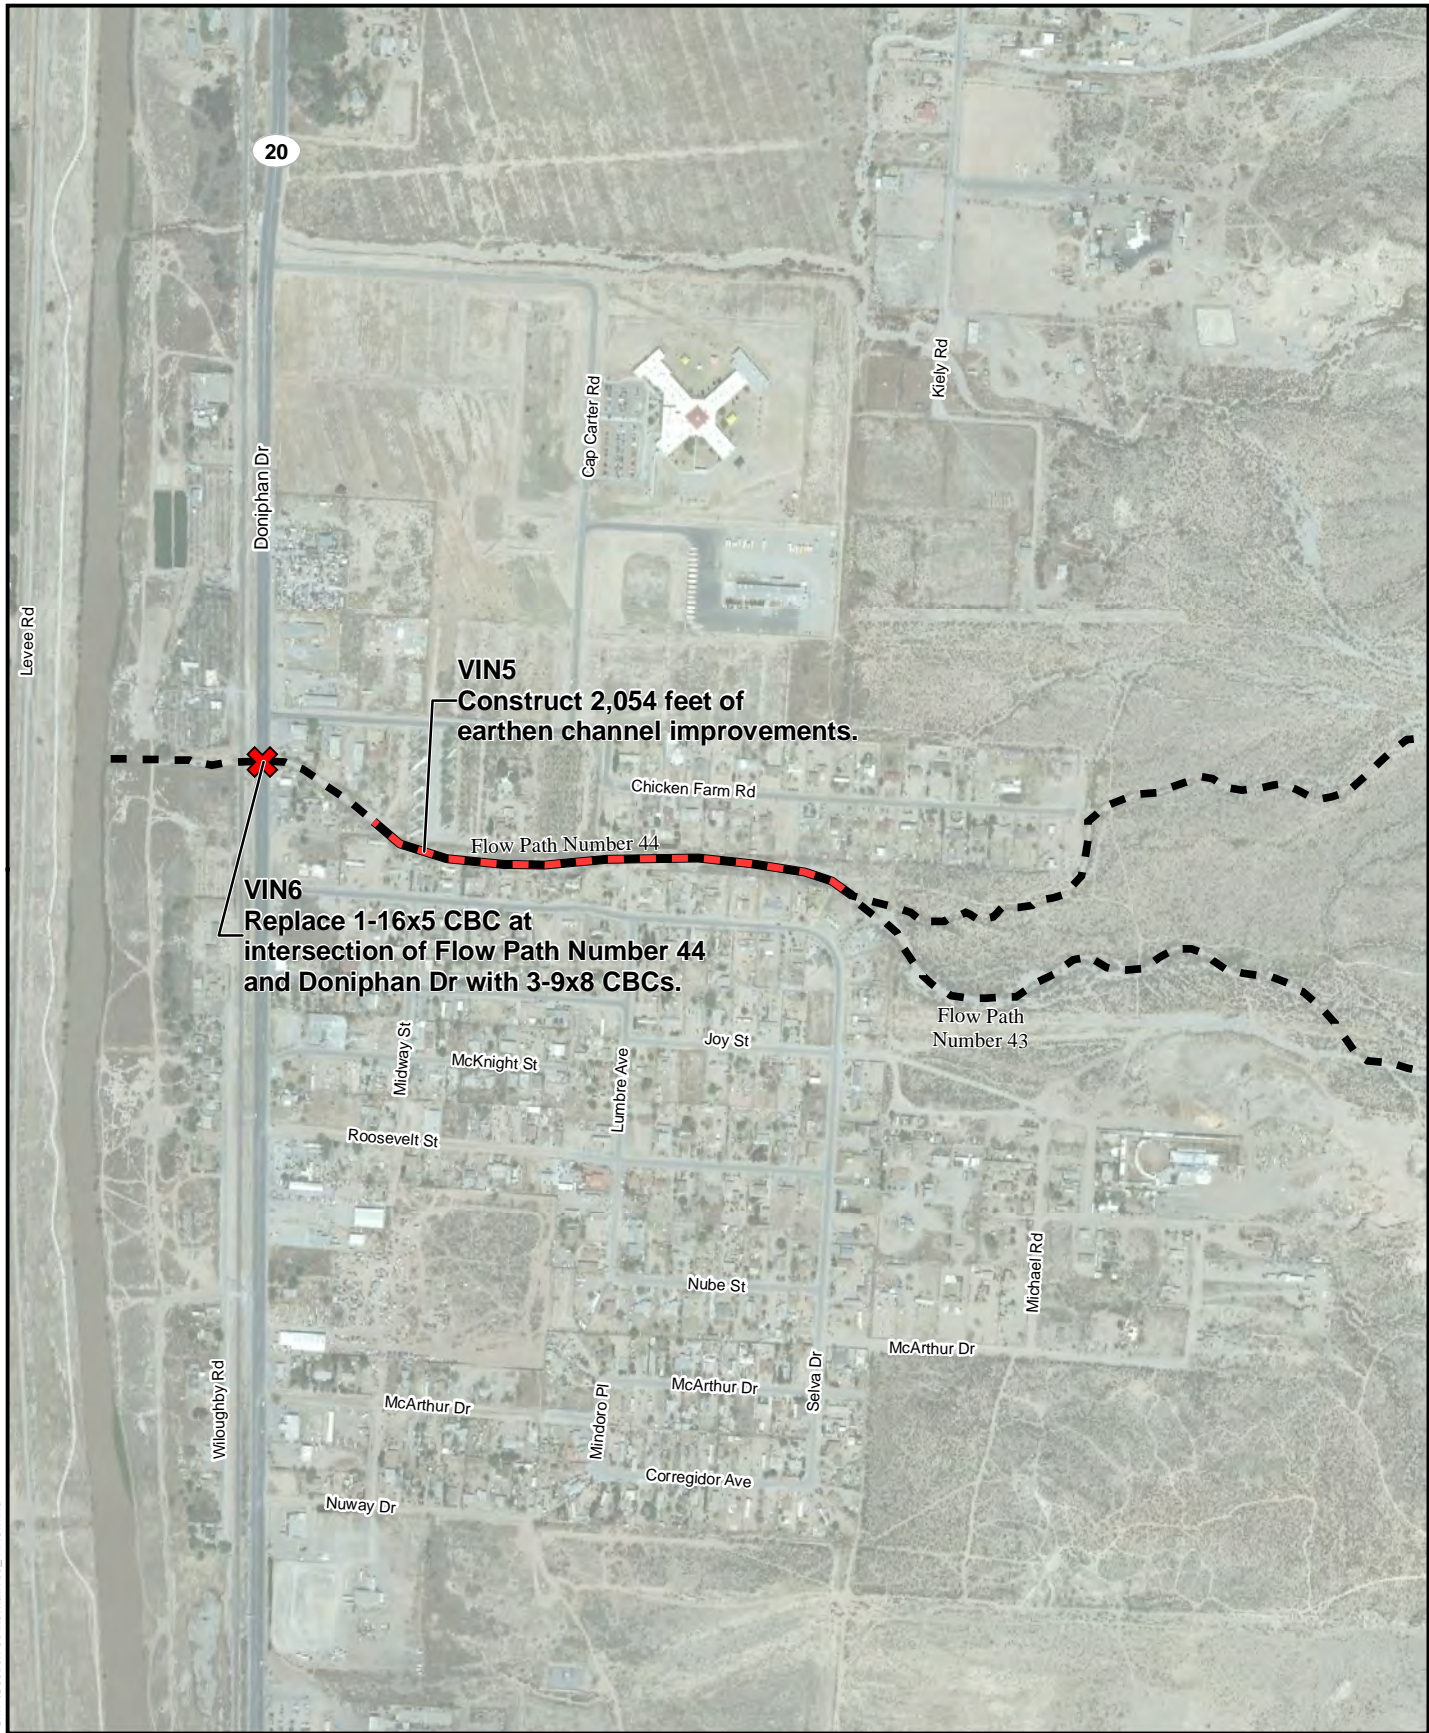
VIN5
Construct 2,054 feet of earthen channel improvements.

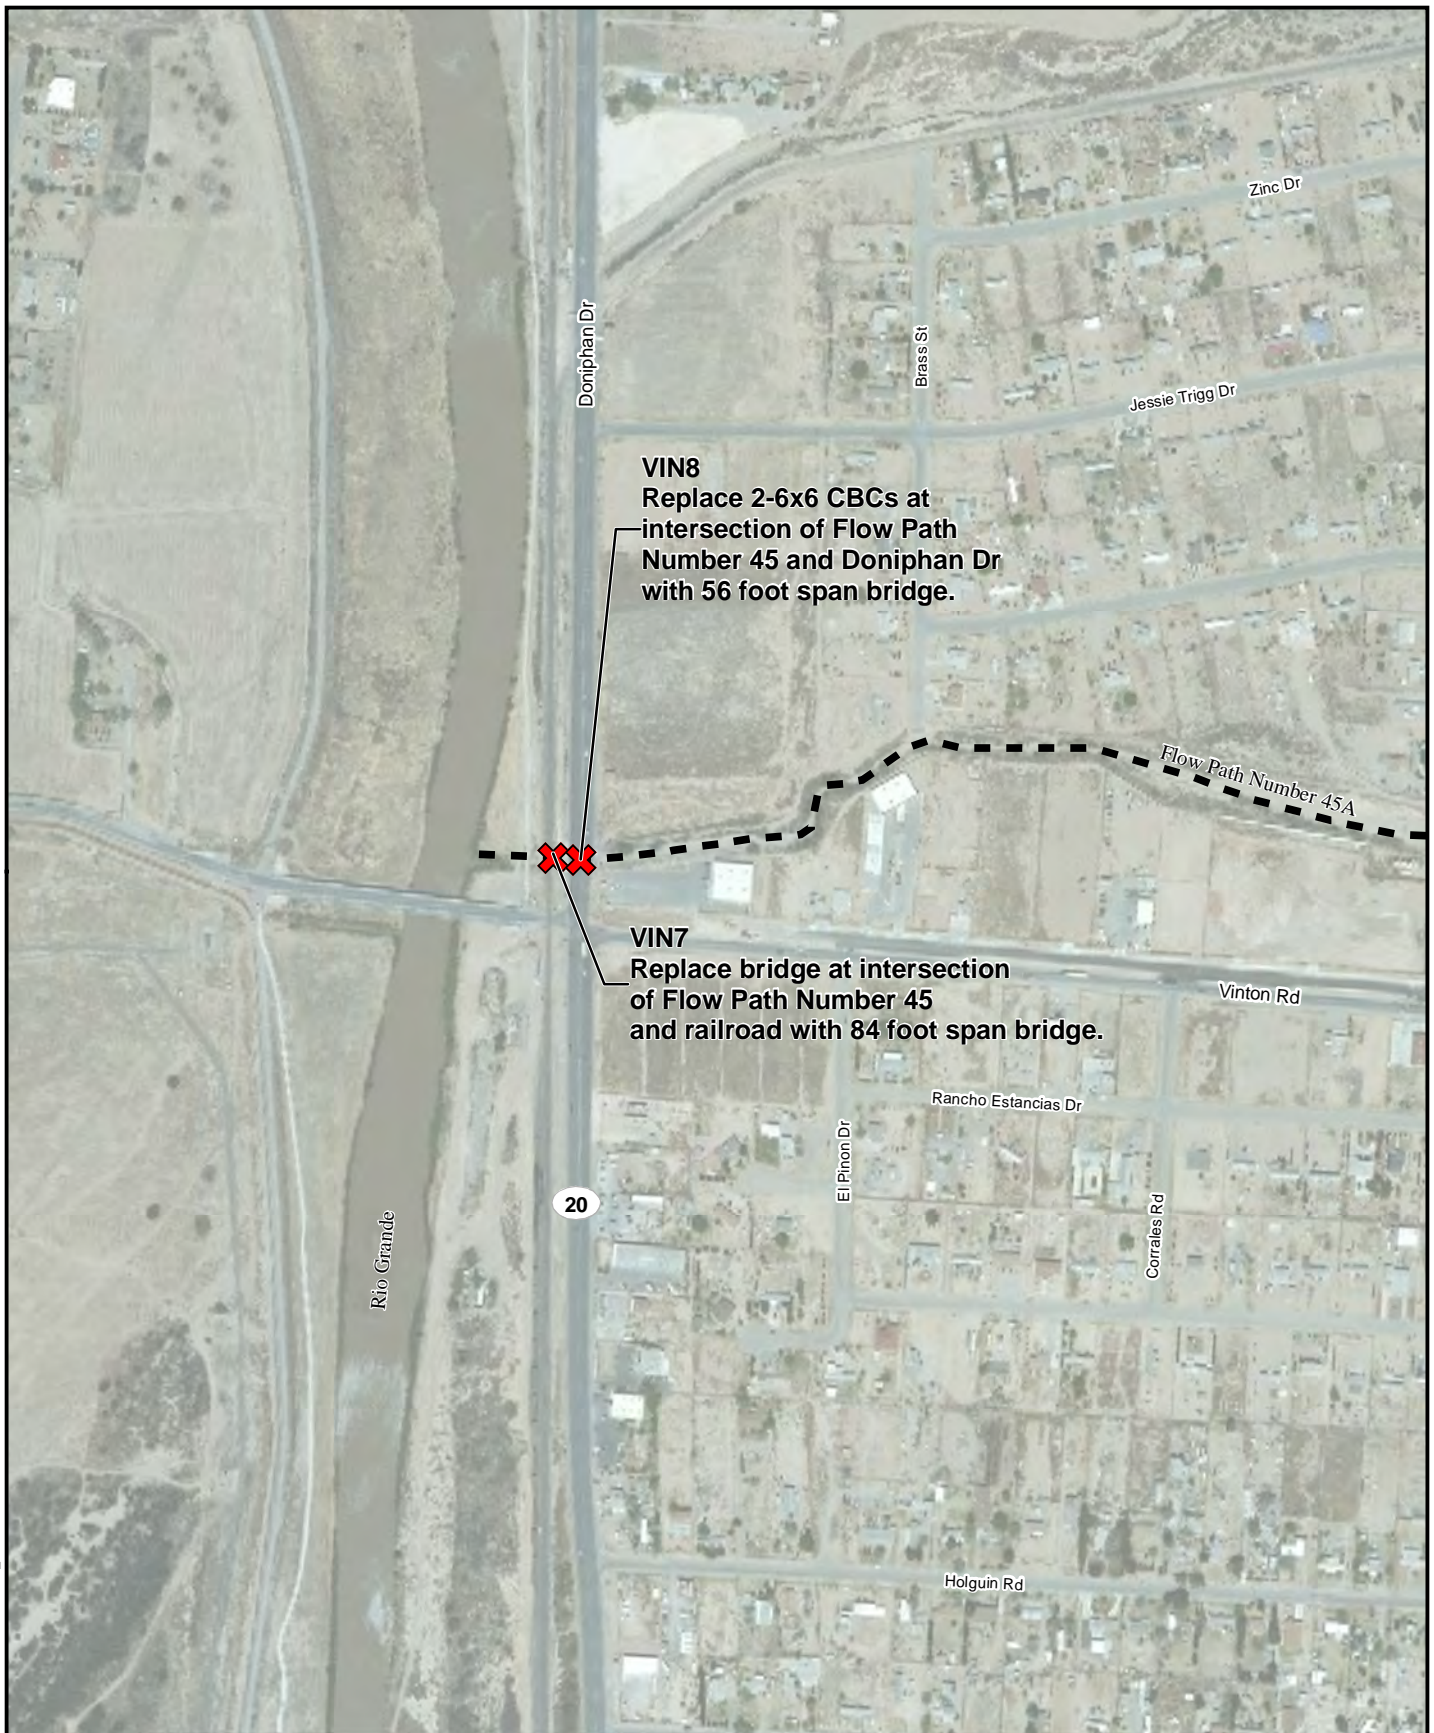
VIN8
 Replace 2-6x6 CBCs at
 intersection of Flow Path
 Number 45 and Doniphan Dr
 with 56 foot span bridge.

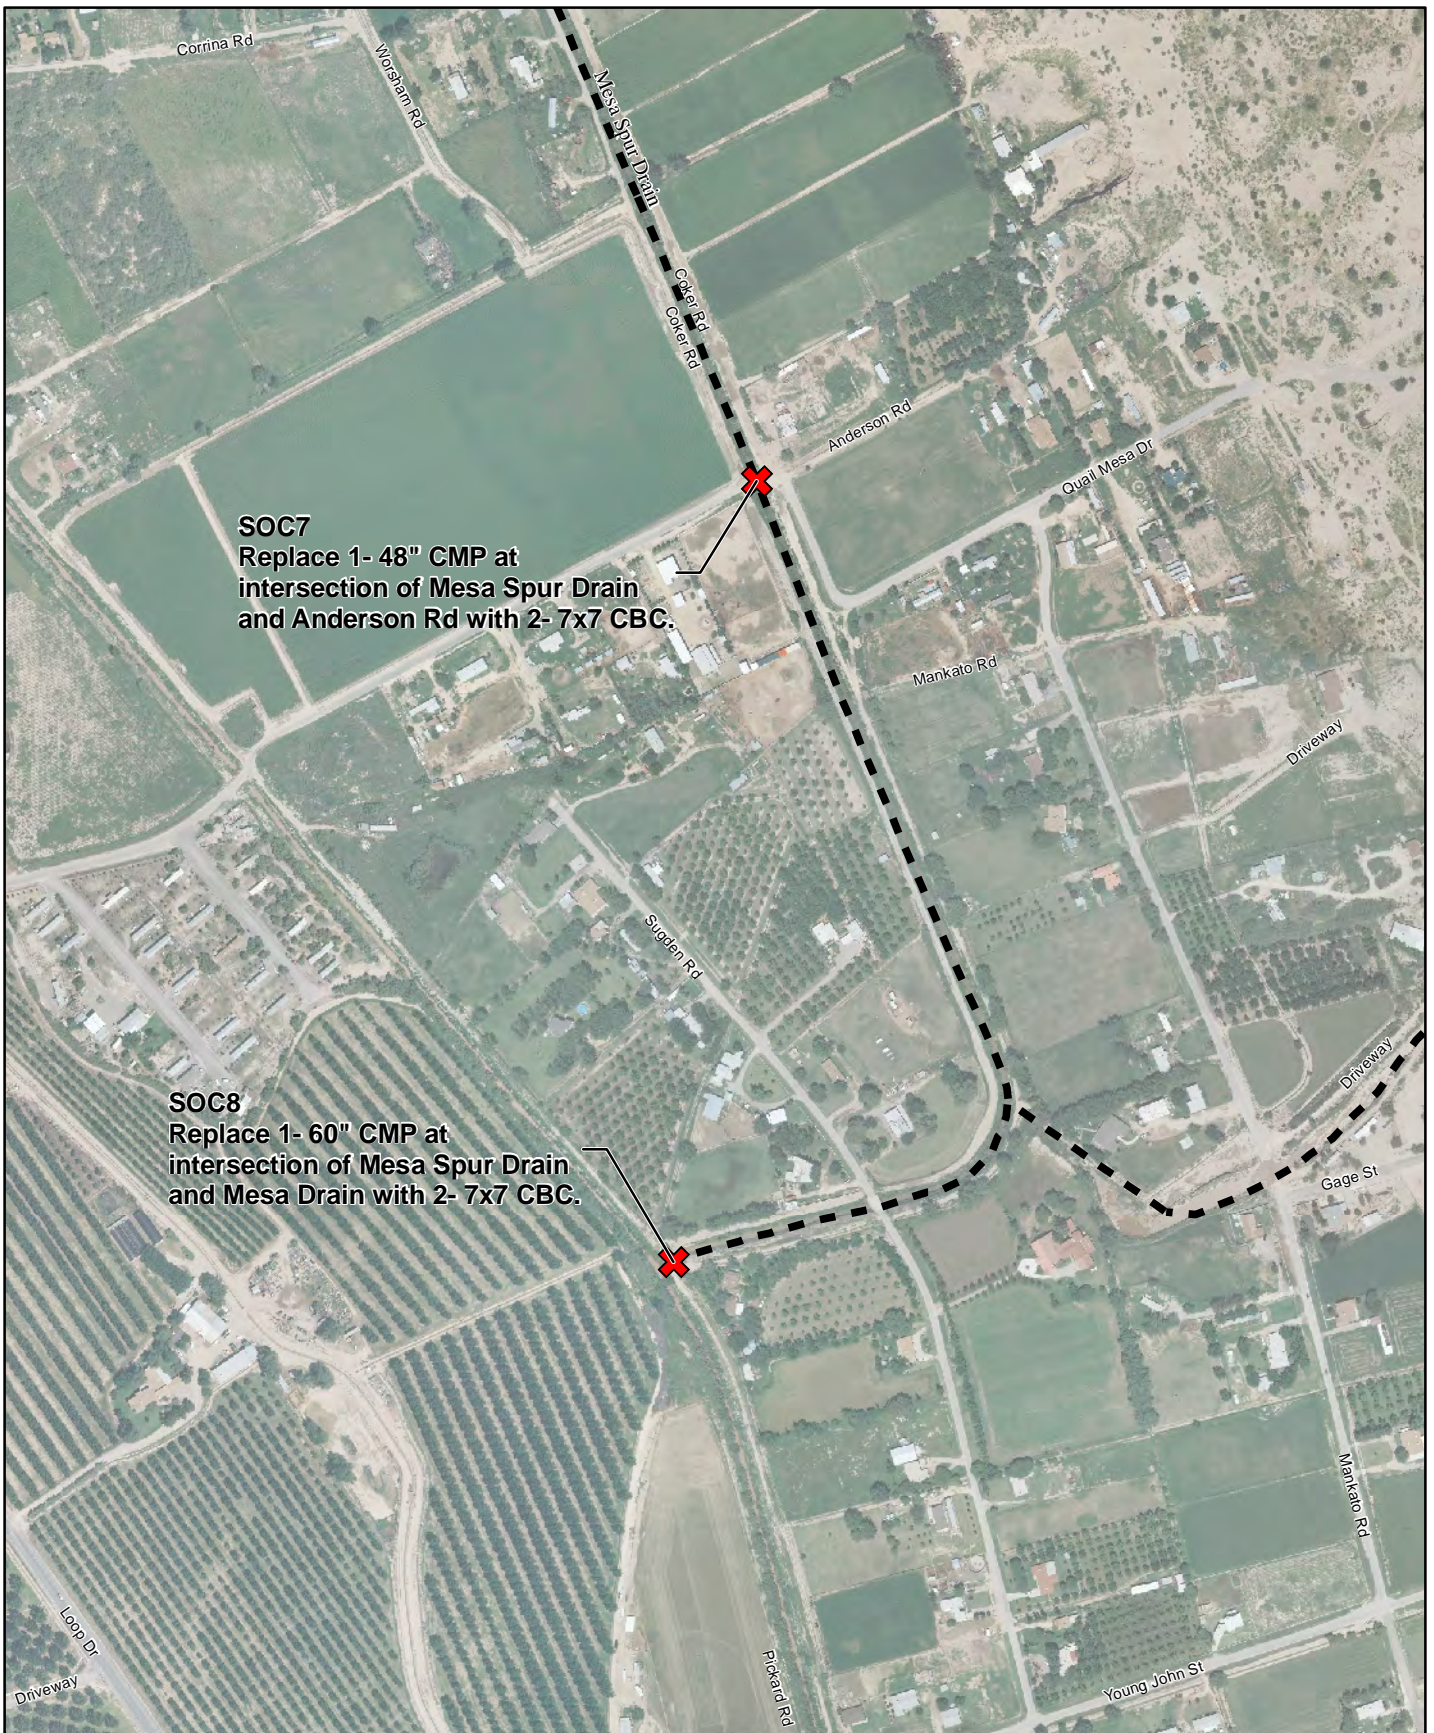
SOC7
 Replace 1- 48" CMP at
 intersection of Mesa Spur Drain
 and Anderson Rd with 2- 7x7 CBC.

Although the crossing (one 48-inch CMP) at the intersection of the Mesa Spur Drain and Anderson Road was not reported to have capacity problems, based on inspection and hydraulic analysis, the culvert does not have capacity greater than or equal to that of the channel. If the Mesa Spur Drain was flowing bank-fill, this crossing would restrict the capacity of the channel and potentially cause flooding of the residential and agricultural lands adjacent to the channel.
